Residential Site Investigation Report

Client: Malcolm Kleu

Site Address: 118 Hillside Lane
Gulgong, NSW 2852

Our Reference: 39471-GR01_A

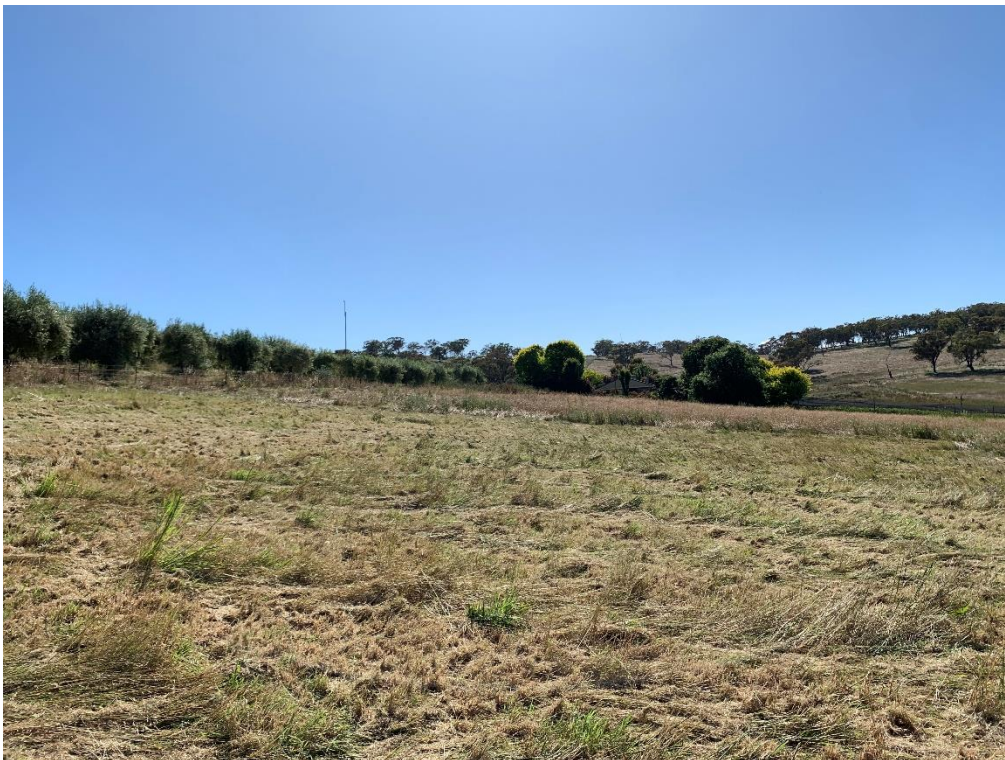
The site consists of light scattered grass and weed cover with no trees onsite.

The site is sloping moderately to the south. The block has existing rural farmland surrounding the area.

Plate 1 – South facing view

Any trees noted to be within the building zone, should be removed and the excavation remaining should be backfilled with natural material and reinstated in layers to a minimum of 95% Standard Maximum Dry Density

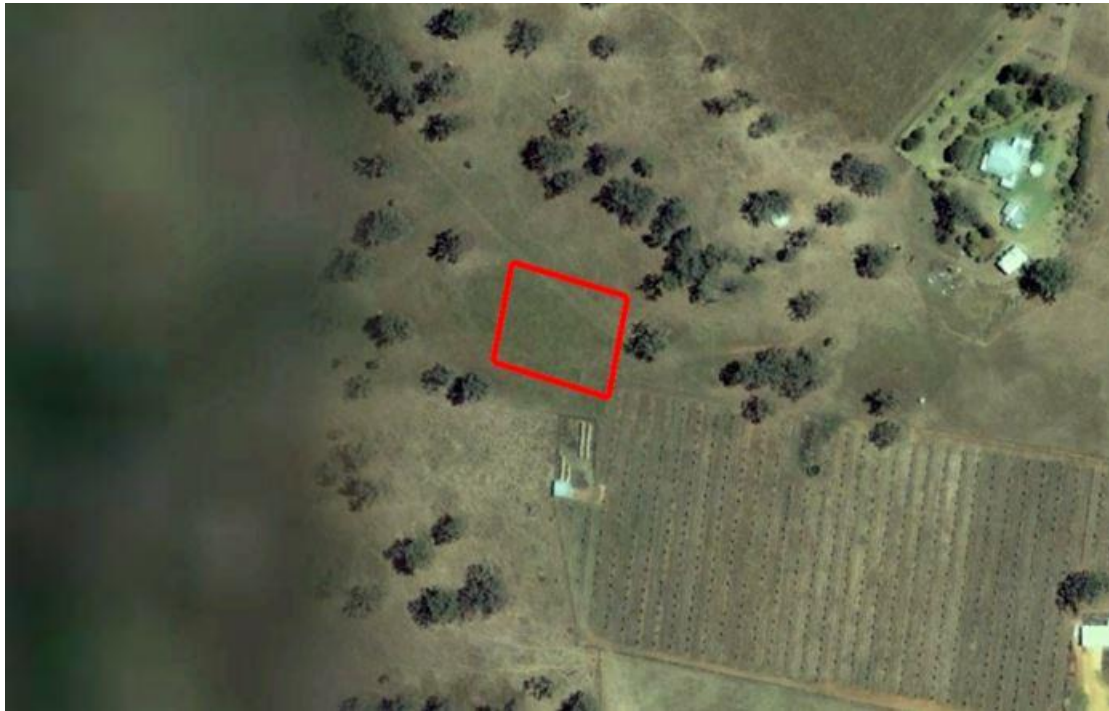
A review of Google Earth imagery of the site indicates that the site is in similar condition as to when an image was taken in 2003. The site is therefore assumed to be natural ground with no recent tree removal or fill placed. Images exist back to 1985, yet the image is not clear enough to determine what was on the site. See 2003 aerial image below:

Plate 2 – Aerial Image 2003, Courtesy Google Earth.
