# Residential Site Investigation Report

**Client:** Ryan Jones

**Site Address:** 1318 Henry Lawson Drive,  
St Fillans NSW 2850

**Our Reference:** 45588-GR01\_A

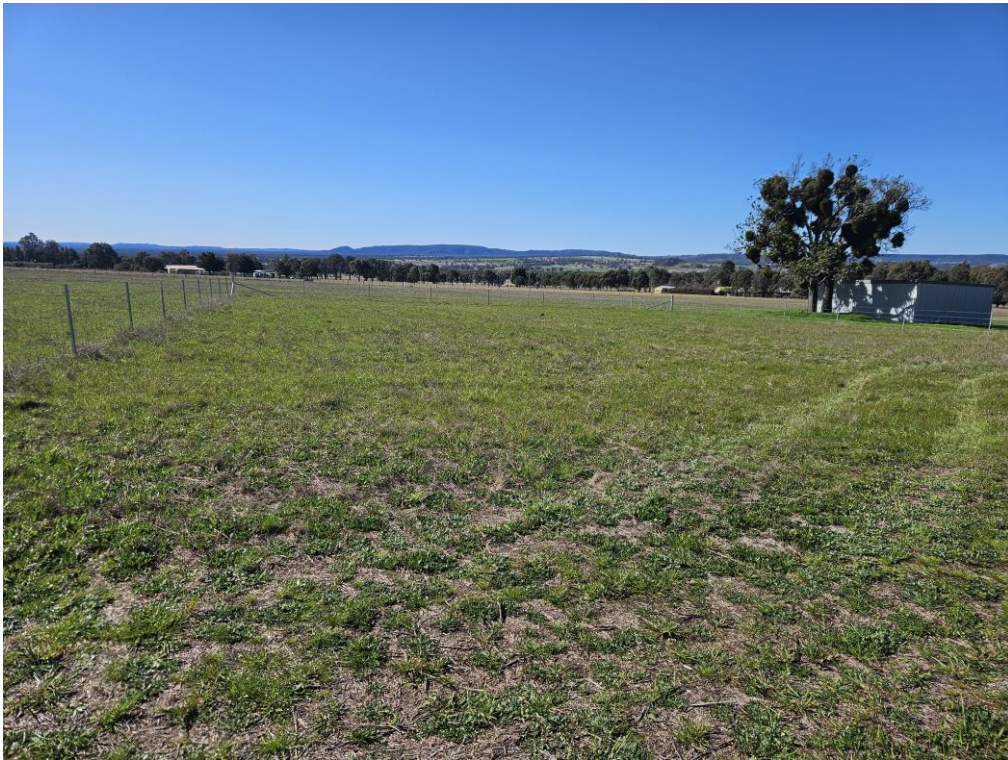
Plate 1 – North facing view

The site consists of light grass and weed cover with no trees onsite.

The site is sloping slightly to the east. The block has existing rural farmland surrounding the area.

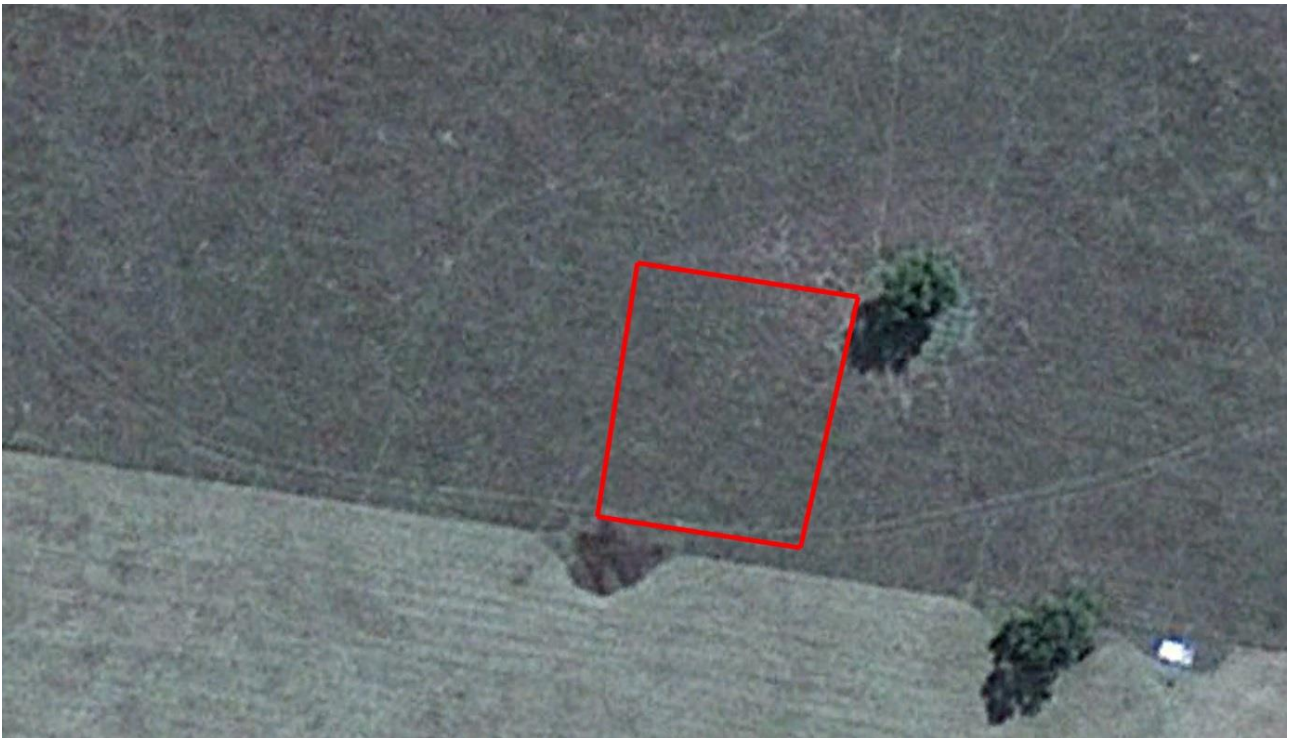
Plate 2 – Aerial Image 2009, Courtesy Google Earth.

A review of Google Earth imagery of the site indicates that the site is in similar condition as to when an image was taken in 2009. The site is therefore assumed to be natural ground with no recent tree removal or fill placed. Images exist back to 1985, yet the image is not clear enough to determine what was on the site. See 2009 aerial image below:
