AS2870-2011 SITE CLASSIFICATION

Hibbard Homes

Lot 1226, No 18 Margaret Lane
Caerleon NSW

AS2870 Site Classification
Class P
Estimated AS4055-2021 Wind Classification
N2

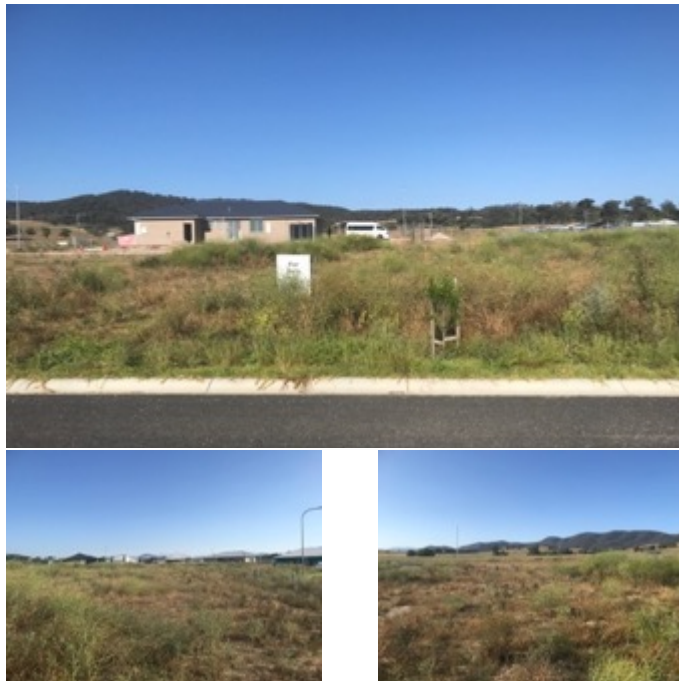
SITE PHOTO:

Site Features:	Vacant Site with grass
Site Drainage:	Poor to Fair (At time of testing)
Ground Slope	Gentle
Water Table/Seepage:	Not present
Fill:	Yes
Rock:	No
Slope Instability Assessment:	Not commissioned
Exposure Classification:	Not Commissioned
