Residential Site Investigation Report

Client: David Coleman

Site Address: 61 School Lane,
Budgee Budgee NSW 2850

Our Reference: 45210-GR01_A

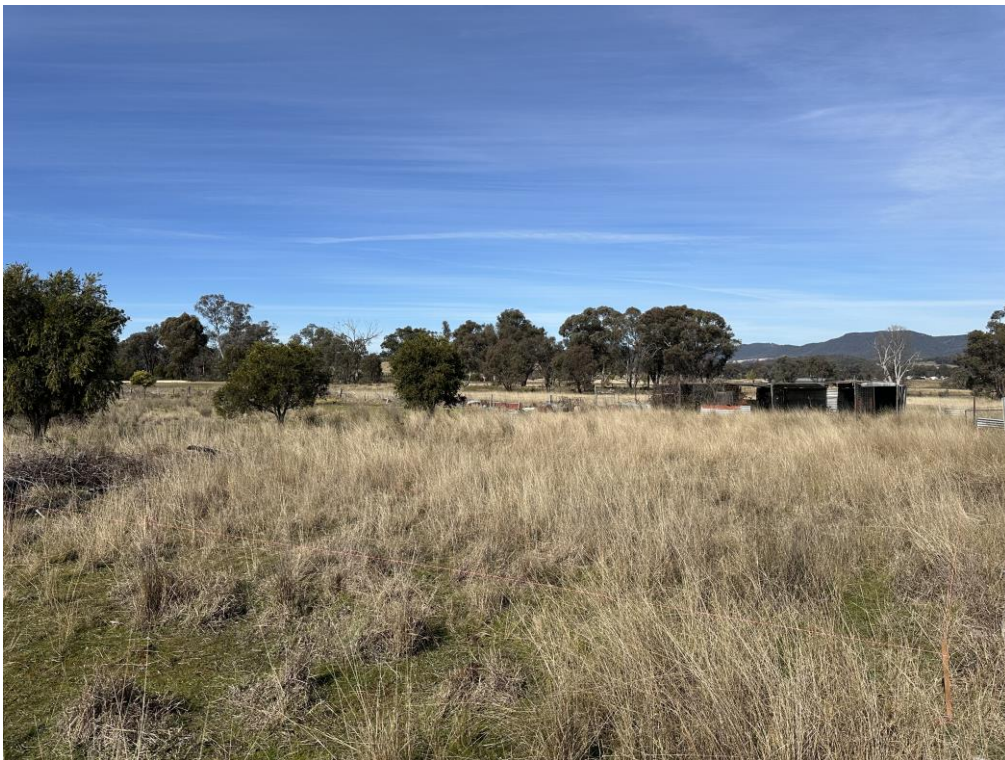
Plate 1 – South facing view.

The site consists of moderate grass and weed cover with mature trees scattered over the site.

The site is sloping slightly to the north west. The block has existing dwelling on block with rural farmland surrounding the area.

Any trees noted to be within the building zone, should be removed and the excavation remaining should be backfilled with natural material and reinstated in layers to a minimum of 95% Standard Maximum Dry Density.

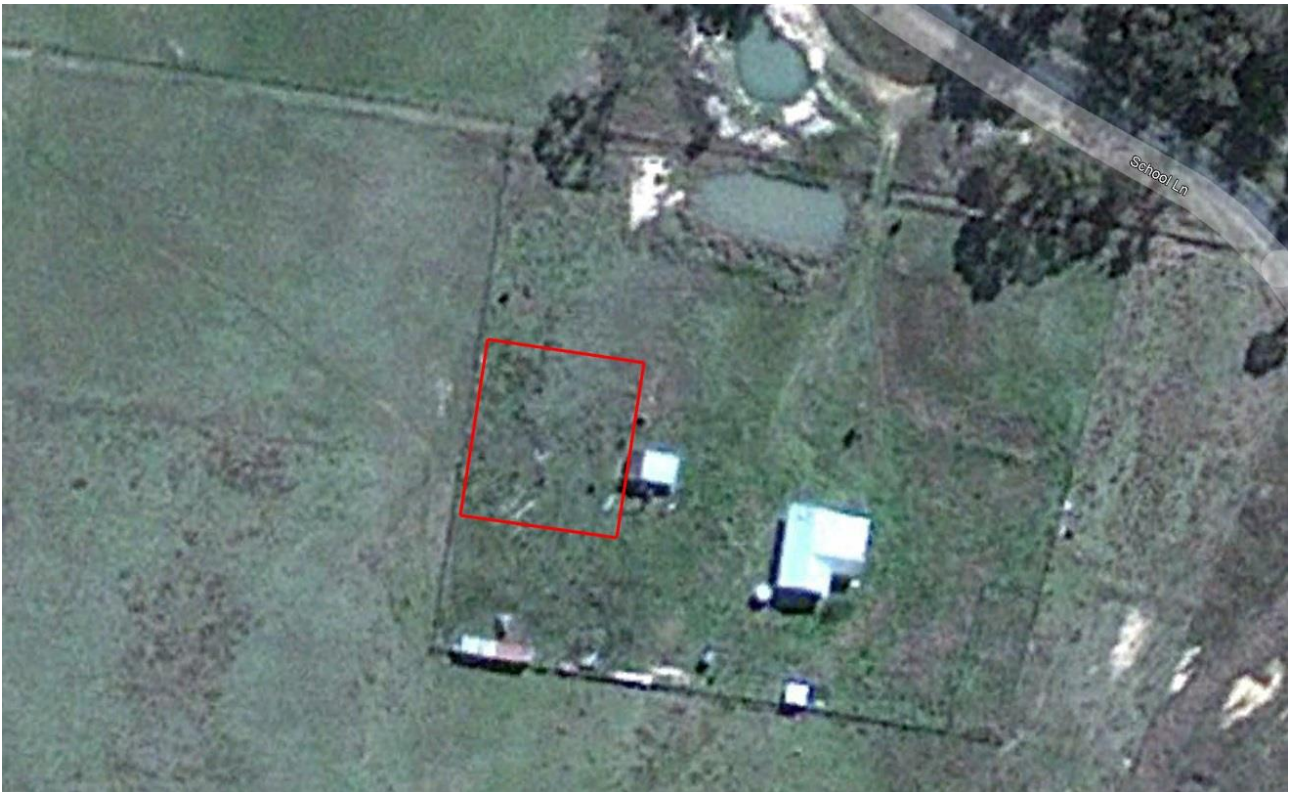
Plate 2 – Aerial Image 2009, Courtesy Google Earth.

A review of Google Earth indicates that the site is in similar condition as to when an image was taken in 2009. The site is therefore assumed to be natural ground with no recent tree removal or fill placed. Images exist back to 1985, yet the image is not clear enough to determine what was on the site. See 2009 aerial image below:
