# Residential Site Investigation Report

435 Kaludabah Road,  
Piambong NSW

(Our Reference:38881-GR01\_A)  
© Barnson Pty Ltd 2022. Confidential.

<b>Project Name:</b>	435 Kaludabah, Piambong NSW 2850
<b>Client:</b>	Grahame Heap
<b>Project No.</b>	38881
<b>Report Reference</b>	38881-GR01_A
<b>Date:</b>	17.05.2022
<b>Revision:</b>	Revision A

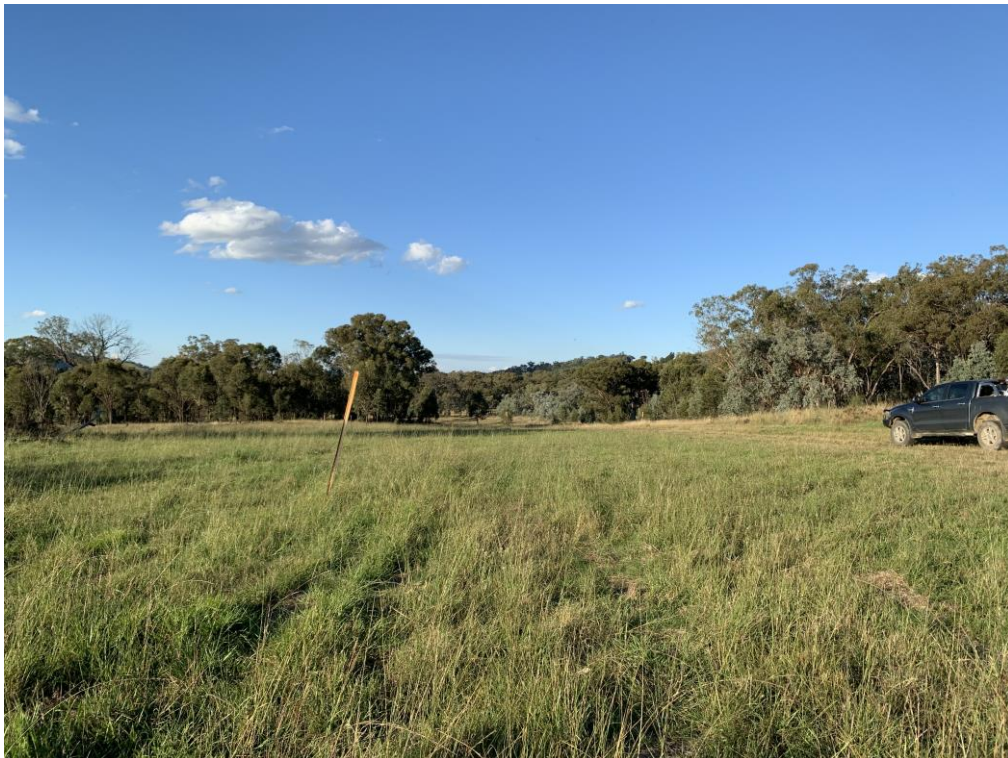
Plate 1 – North facing view

The site consists of moderate grass and weed cover with no trees onsite.

The site is sloping slightly to the north east. The block has existing rural farmland surrounding the area.
