Site Contamination Investigation

Site Address: 127 Gladstone Street, Mudjee

27 March 2024

Project Name:	Preliminary Site Investigation at 127 Gladstone Street, Mudgee
Client:	Capstone Development Group (Rep. Angus Isles)
Project Number:	43539
Report Reference:	43539 ER01_A
Date:	27/03/2024

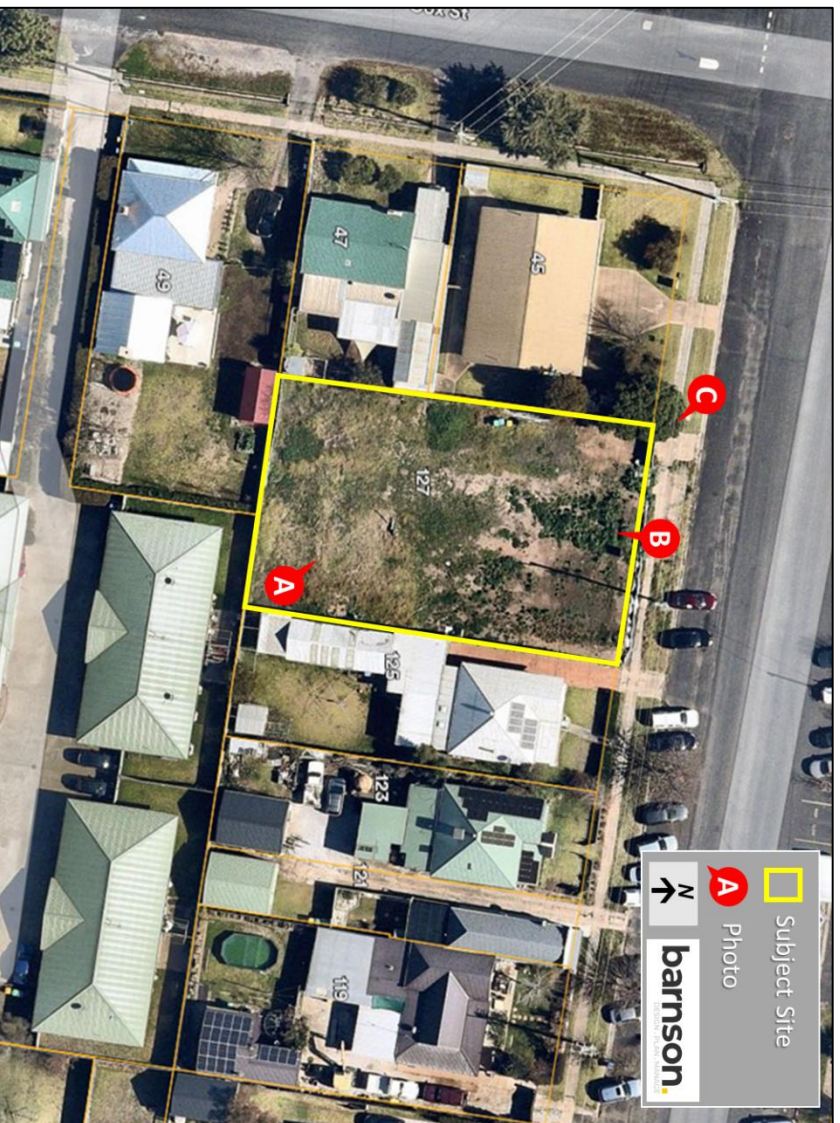
Figure 2.2: Existing Subject Site layout.

Figure 2.2 presents a plan of the Subject Site that is supplemented with photographs showing the different elements of the Site (Figure 2.3 to Figure 2.5). Figure 2.2 includes markers indicating the vantage point and direction of the photographs.

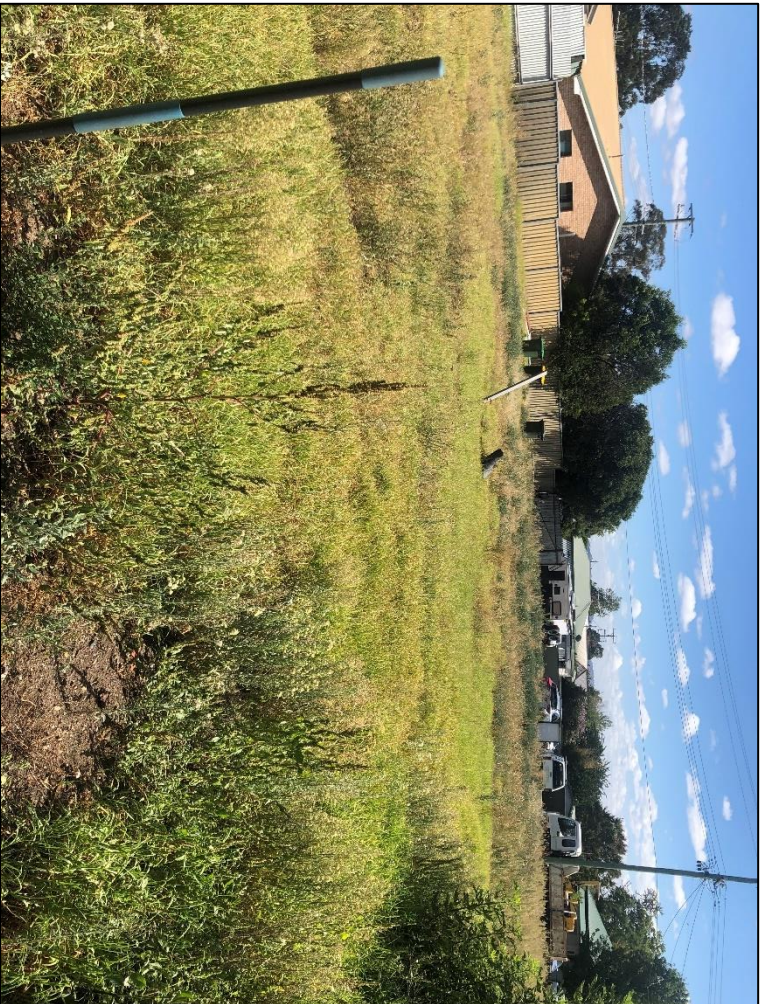
Figure 2.3: Photo A – Photo of the Subject Site, looking north-west.

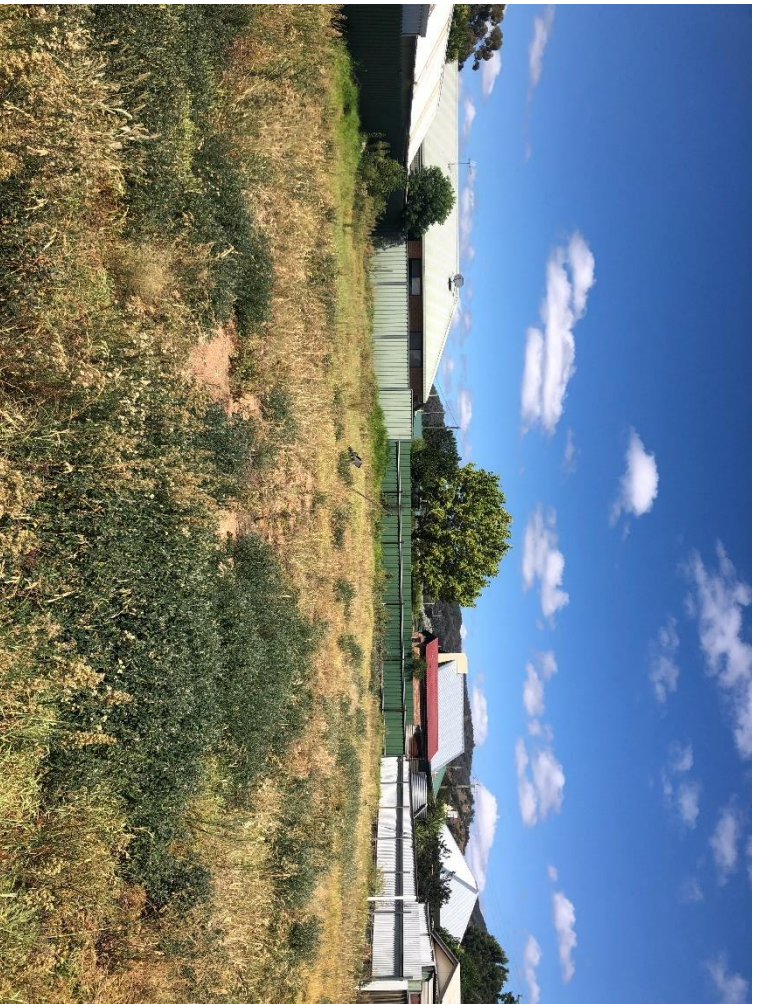
Figure 2.4: Photo B – View across the site, looking from northern boundary.

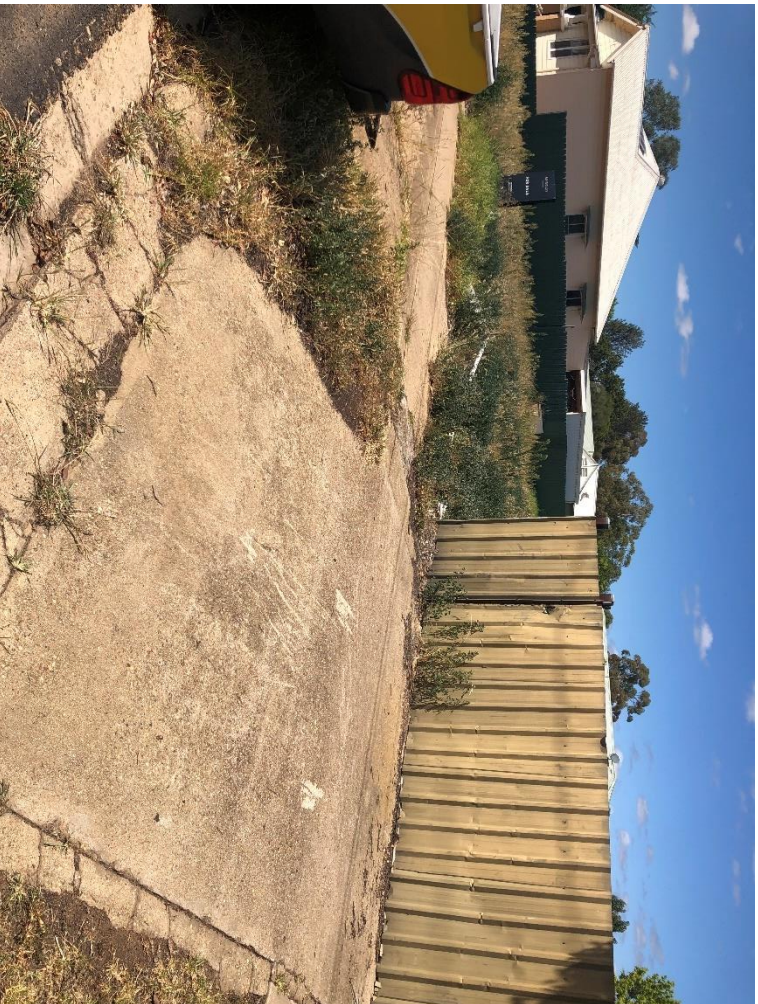
Figure 2.5: Photo C – Photo of driveway access from Gladstone Street.

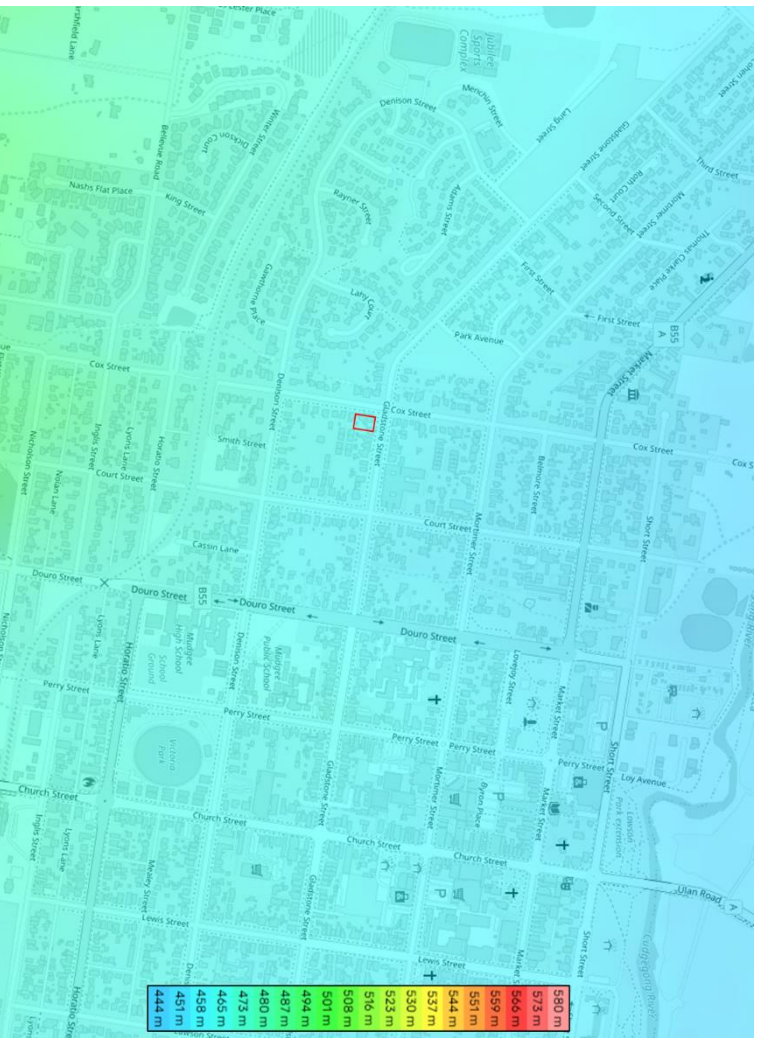
Figure 3.2 presents topographical information overlain on the map of the Subject Site. The presented data shows that the Subject Site is relatively flat with a very gentle slope to the north-east Gladstone Street.

Figure 3.2: Subject Site topography.

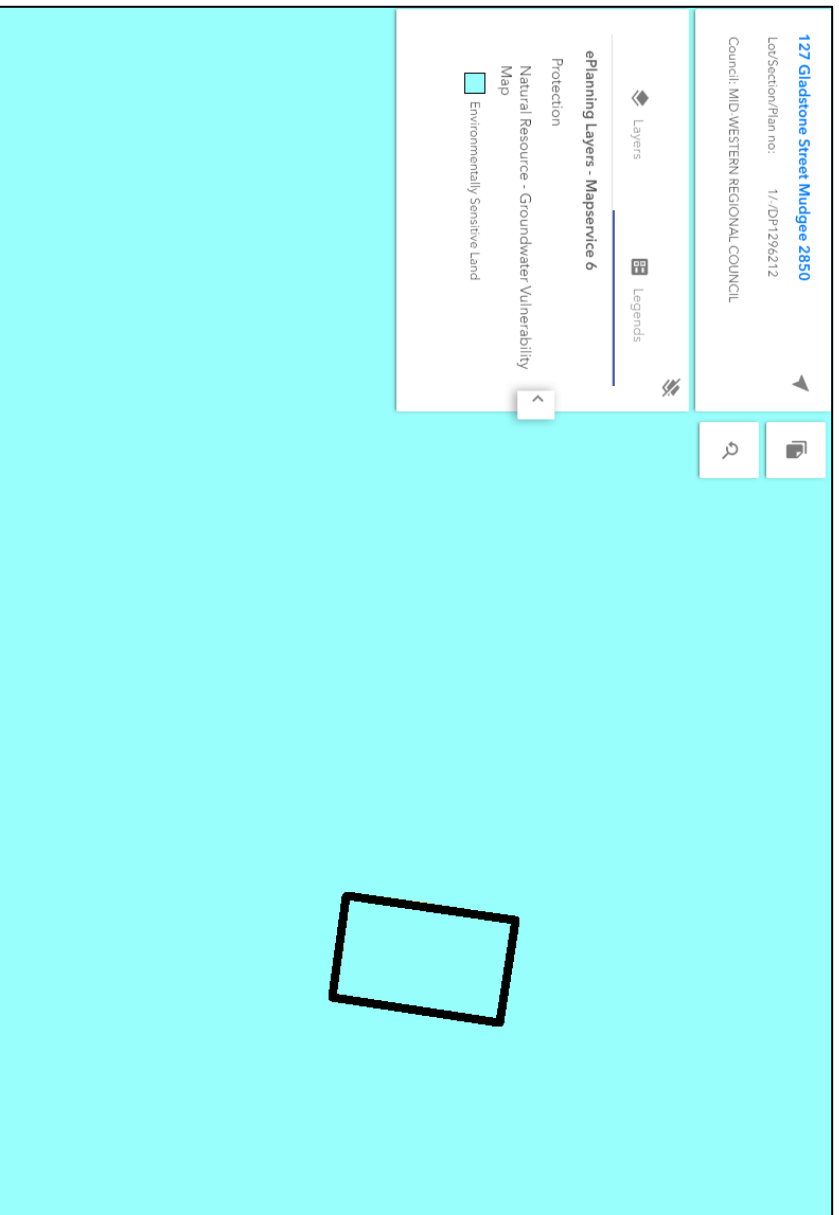
Groundwater Sensitivity mapping obtained from the ePlanning Spatial Viewer, indicate that the Subject Site is located on environmentally sensitive land. Refer to Figure 3.4.

Figure 3.4: Groundwater vulnerability map

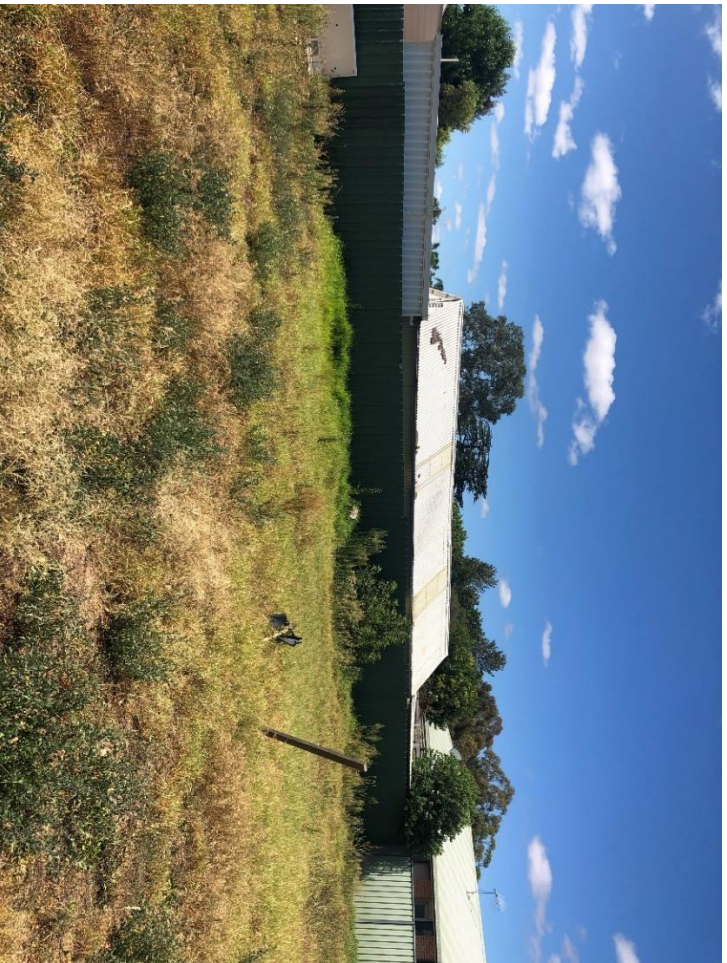
Figure 5.1: Photo of the somewhat managed weeds.

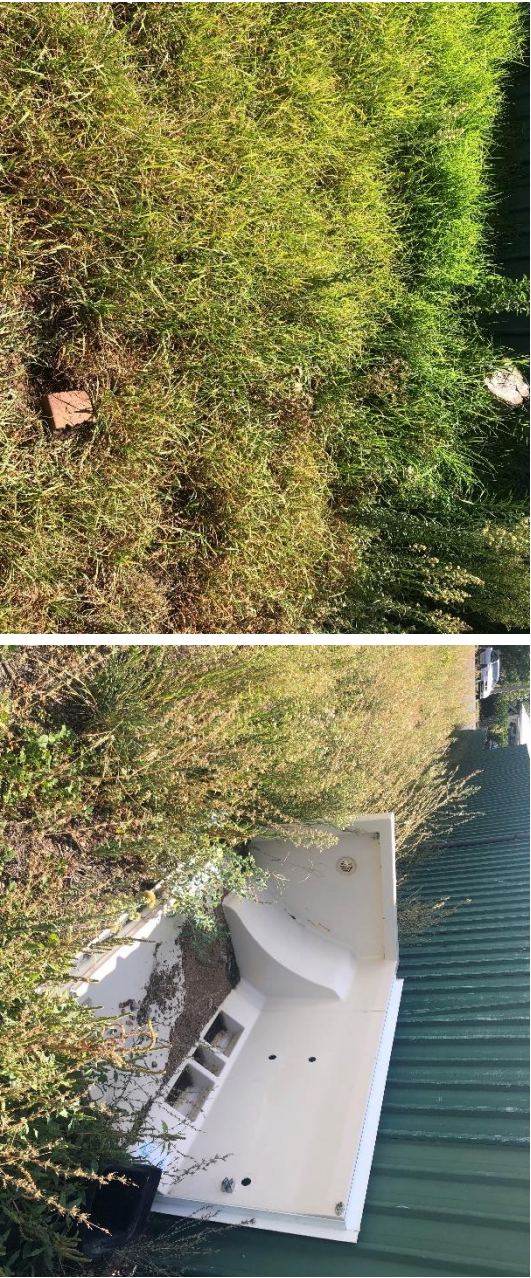
Between 2017 and 2024, an existing dwelling and associated structures onsite have been demolished with the site now vacant. The potential presence of hazardous materials (e.g. asbestos and lead paint) in the structure of former buildings at the Subject Site could contribute to the introduction of these substances into the surface soils of the site as a result of demolition of these structures.

Figure 5.2: Demolition waste.

- It is further recommended that any remaining wastes and the mound of soil stockpiled along the rear fence of the Subject site be appropriately classified and disposed to a facility licenced to accept the waste.

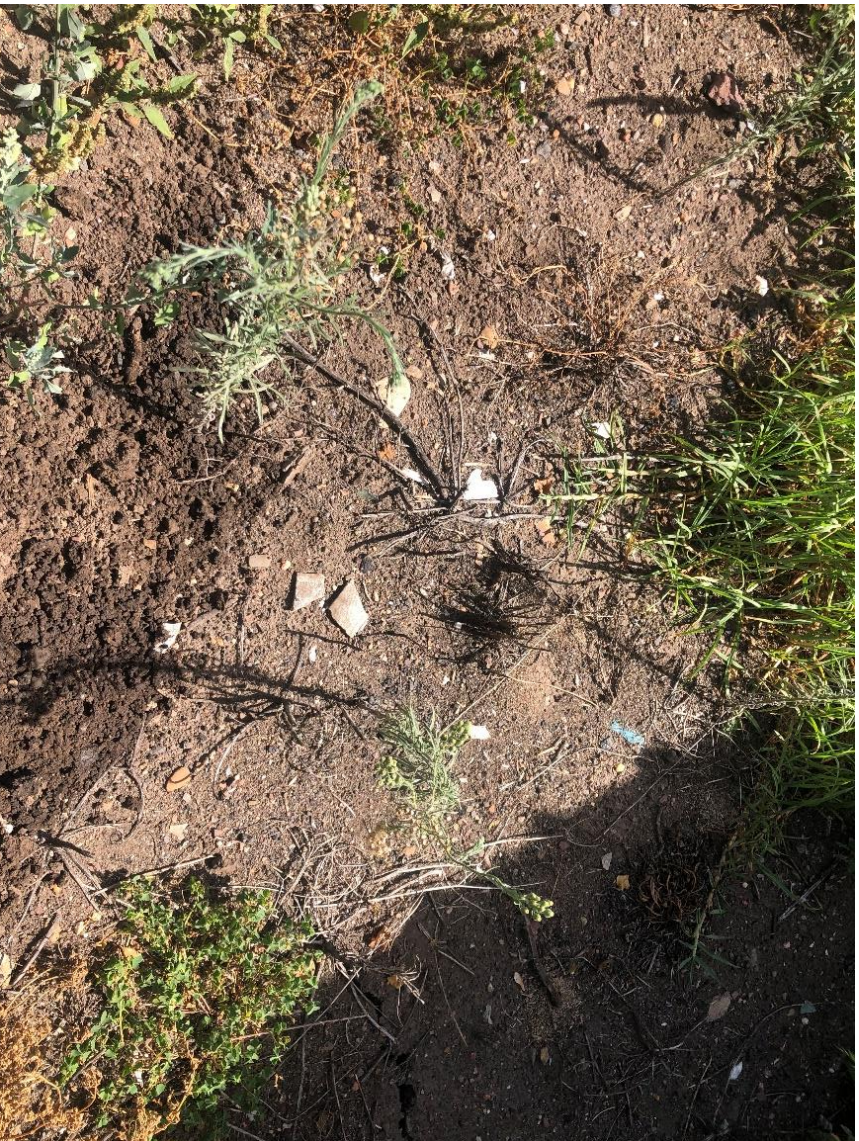
- The Subject Site is not fenced and access to the site is not controlled.
- At present, the subject site is covered in un-maintained grasses and weeds (Figure 5.1).
- Building waste evident in several different locations over the Site (Figure 5.2).
- Fragments of fibre reinforced cement sheeting was observed in several locations (Figure 5.3)

Figure 5.3: Fibre reinforced cement sheet fragments.

- The presence of asbestos containing material (ACM) as fragments on surface was confirmed. The proposed development will require excavation of the site which will disturb the surface fragments. Although broken, the bonded ACM fragments appear in reasonable condition and are not easily crumbled i.e. not fibrous asbestos. There is no evidence from the site history or direct observation during the site walkover that other fibrous asbestos materials (such as insulation or woven materials) are present on the site. Soil samples analysed for asbestos confirmed no fragments or fibres are present in the soil.

It is recommended that the fragments of asbestos containing material be removed and appropriately disposed. It is further recommended that any remaining wastes and the mound of soil stockpiled along the rear fence of the Subject site be appropriately classified and disposed to a facility licenced to accept the waste.

- The asbestos containing material (ACM) at the Subject Site, requires specialist attention during any removal or remedial action. It is recommended that during any removal of waste from this area, the ACM be removed and transported to a landfill, licensed to accept the waste, for disposal. The removal and disposal task can be undertaken by either a competent person or a licensed asbestos removalist.

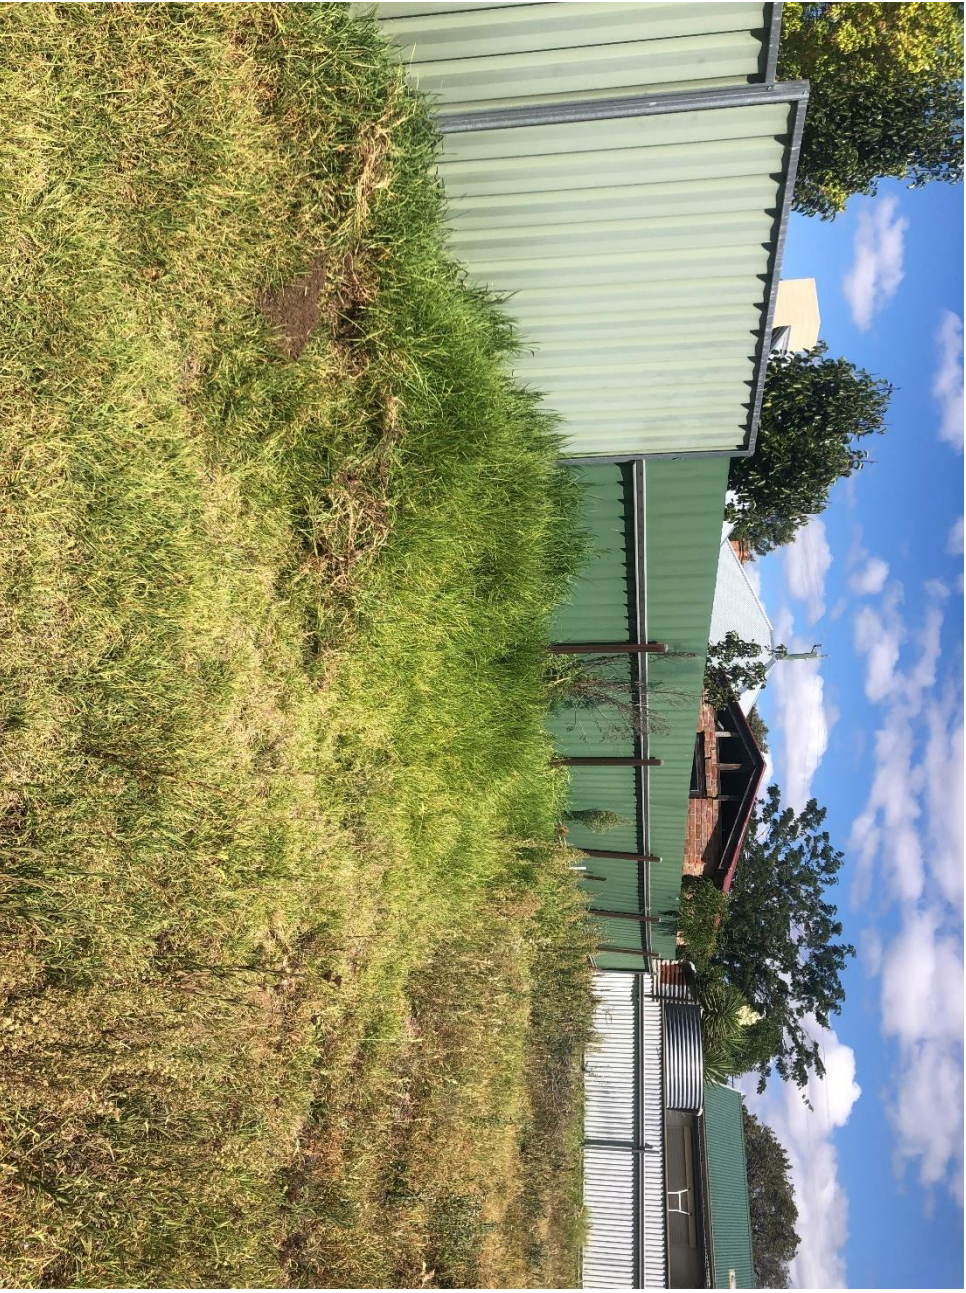
- A mound of soil located along the southern fence line of the Subject Site appears to have been formed from pushed to this location from the rear part of the Subject Site. The mound contains rocks, plastic, metal (cutlery) and paper and appears to have been an attempt to tidy-up the lot. The mound was quite overgrown but was excavated by hand at a series of 8 locations along its length. The excavations revealed mainly soil and wastes. No demolition waste were observed. It is reasoned that the soils were stockpiled in this manner before the demolition of the dwelling.

Figure 5.4: Long overgrown mound of soil and waste along the rear of the property.

- The elevated concentrations of lead and zinc compounds relate to the mound of soil observed along the rear fence of the subject site, as do the detected concentrations of PAHs and hydrocarbons. It appears that surface soils that potentially may have included heavy metal and hydrocarbon contaminants as a result of the activities in the back yard of the former dwelling were scraped into the mound along the rear fence. The concentrations of metals and hydrocarbons detected in the samples from this mound of soil are relatively low and are well below the Health Screening criteria.

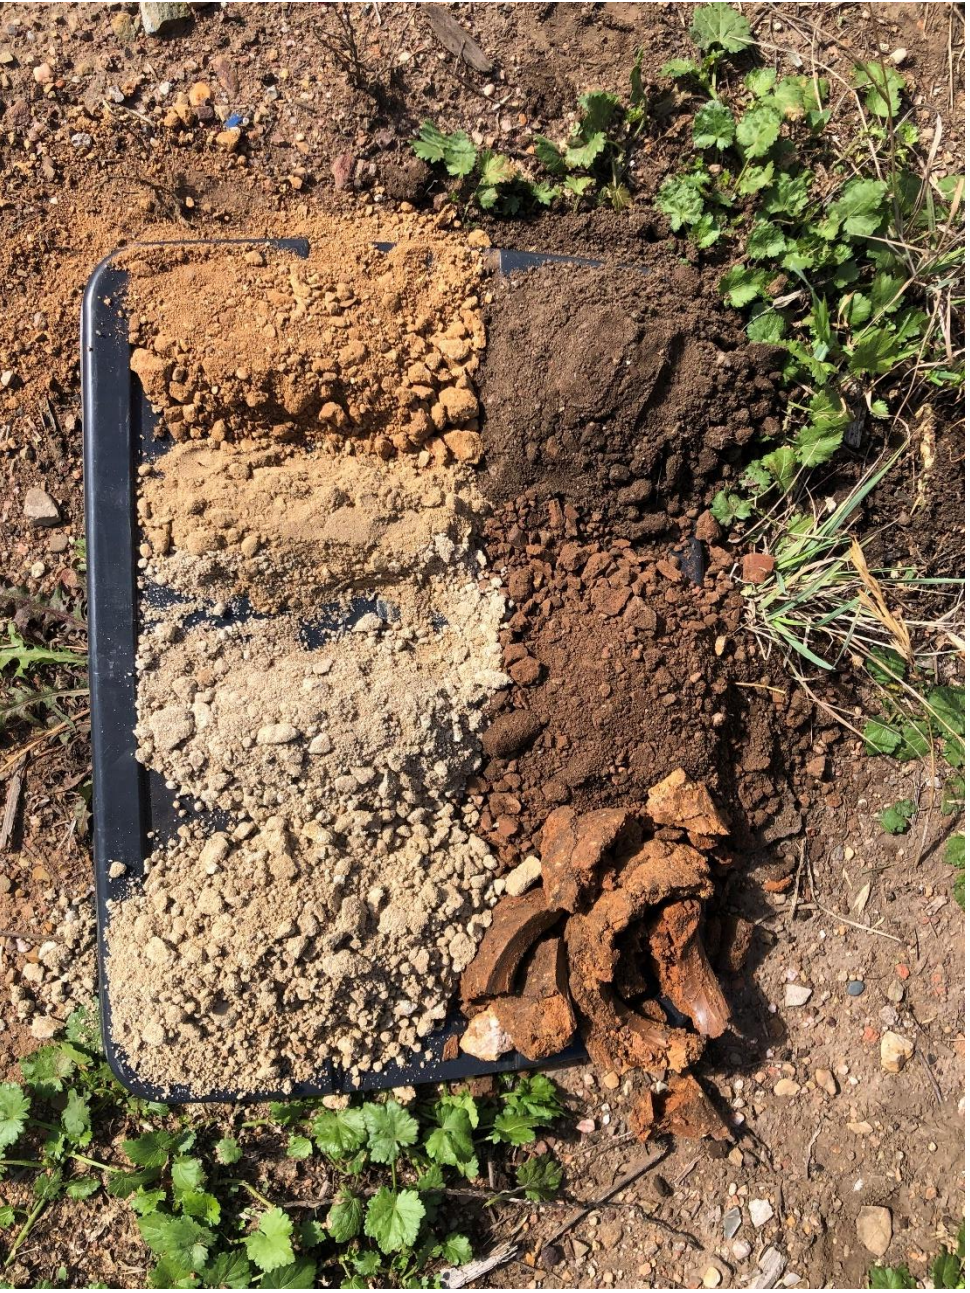
- A geotechnical investigation of the Subject Site indicated no discernable layer of fill material located over the site. The borelogs for the Geotechnical investigation indicate a layer of top-soil underlain by sandy silty clay. Figure 5.5 present a succession of soil samples retrieved from a geotechnical bore to 3m. Heaps of soil represent 500mm intervals from surface (0mm).

Figure 5.5: Soil samples retrieved at 500mm intervals to 3.0m from a geotechnical bore at the Subject Site.
