**Report on Preliminary Geotechnical  
Investigation**

**Proposed Quarry**

**1848 Castlereagh Hwy, Tallawang NSW**

**Project 228775.00**

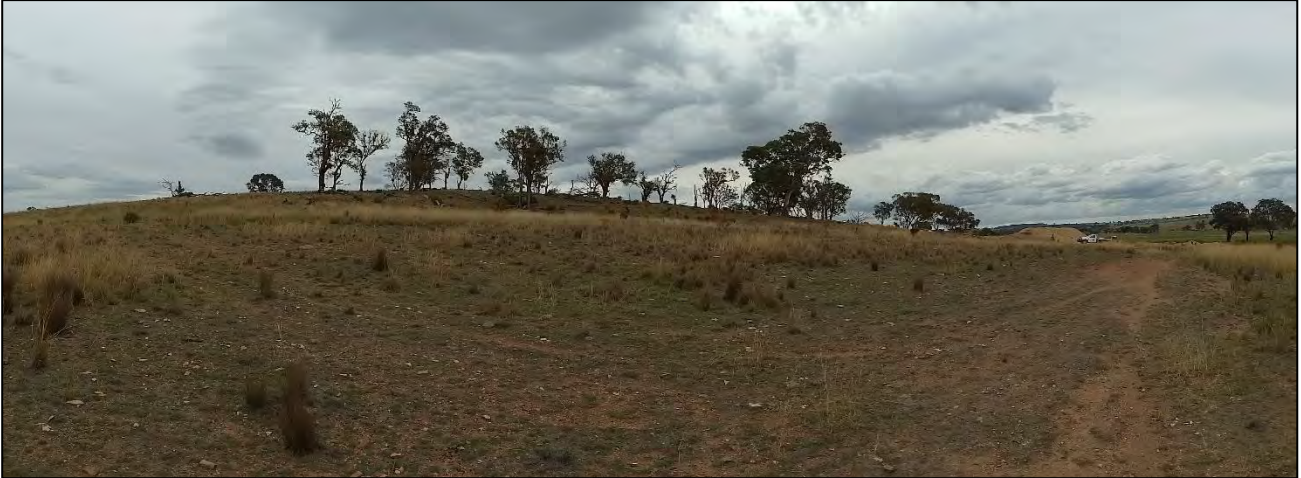
**Figure 1 – Panoramic view of the site, looking north-west**

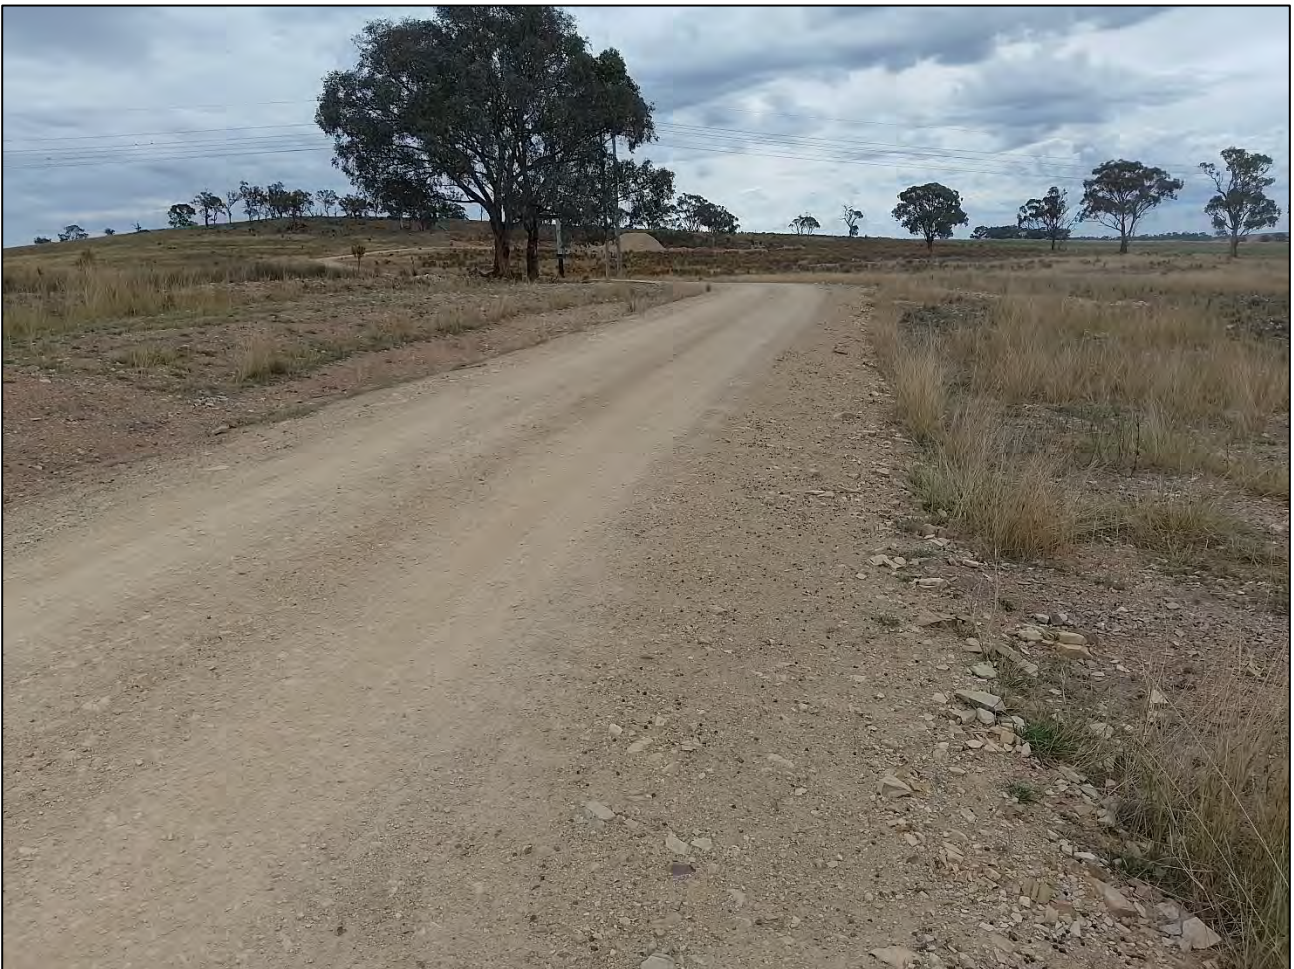
**Figure 2 – View of existing access road, constructed of site won material**

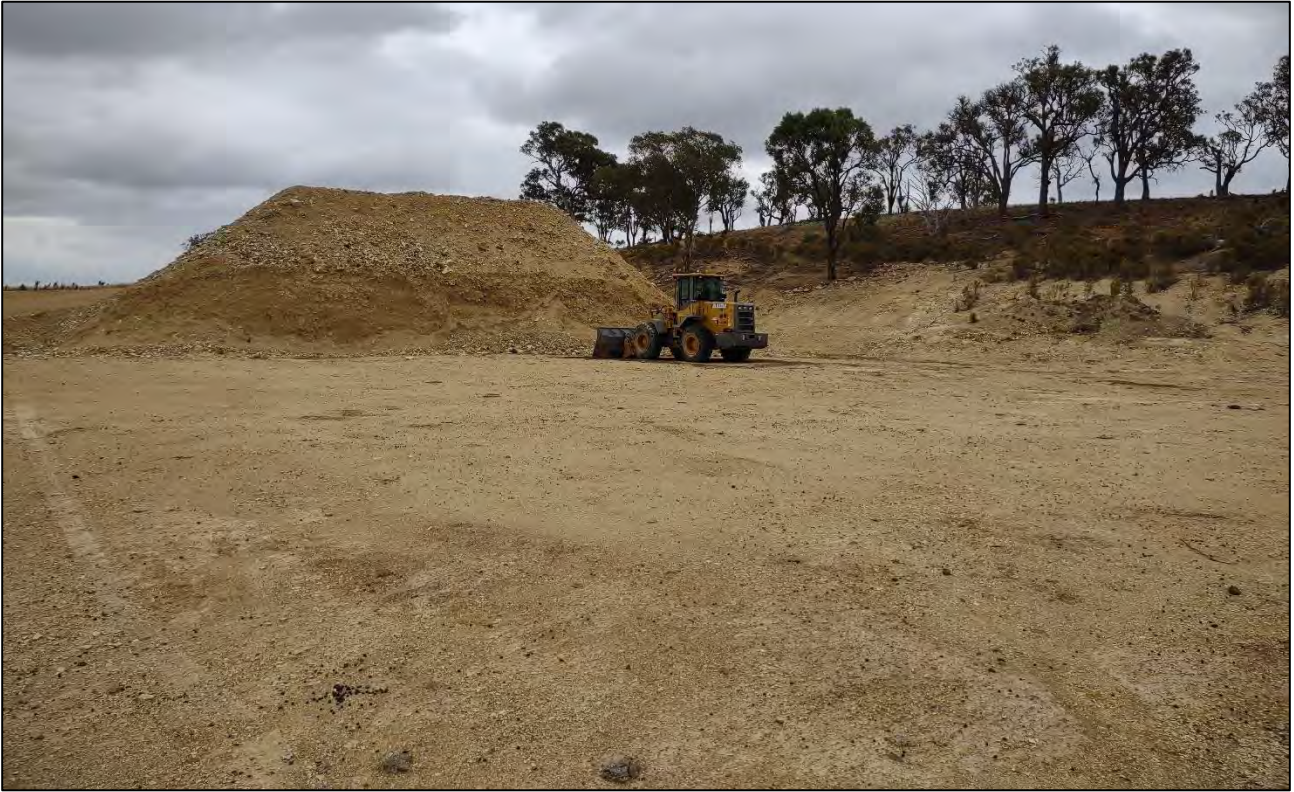
**Figure 3 – View of area of existing excavation and stockpiled material, near Bore 1**

As indicated in Section 2 above, a stockpile of excavated material was present within the central-northern area of the site. It was evident that the stockpiled material had been excavated from an east facing flank of hill in the same area. The stockpiled material comprised phyllite, consistent with that exposed in the adjacent cut batters and encountered in Bore 1.

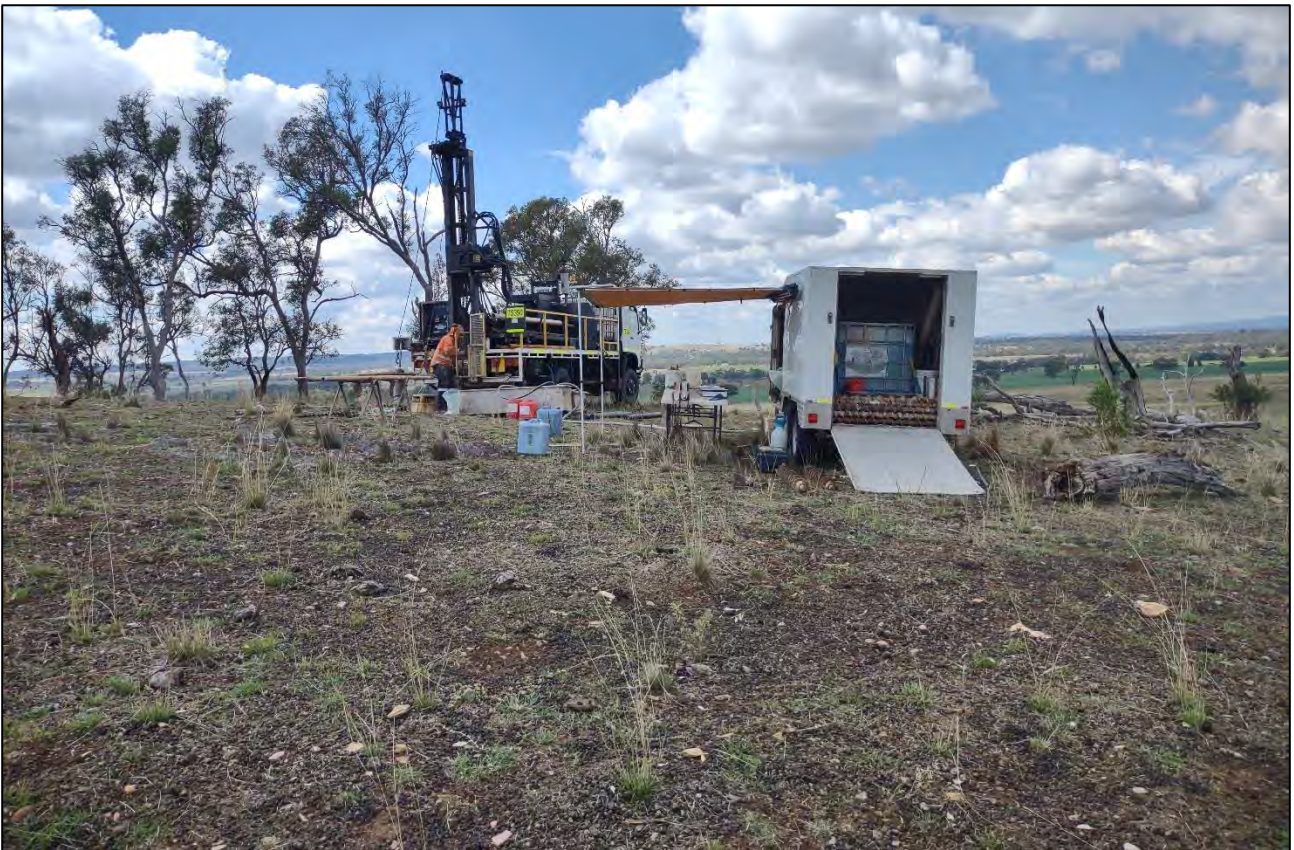
**Figure 4 – View atop hill, Bore 2.**

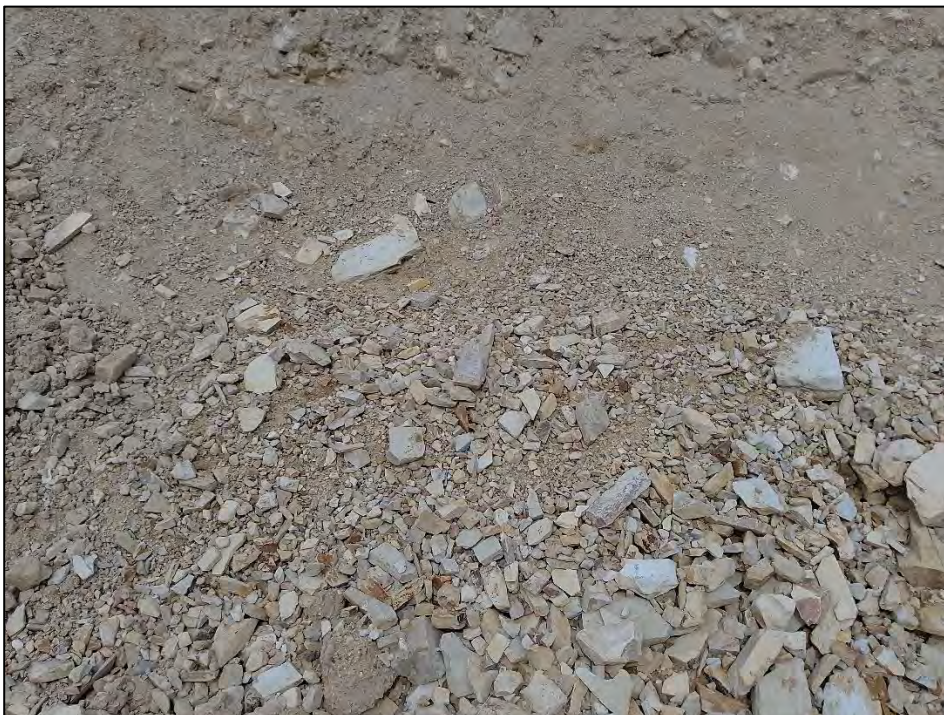
**Figure 6 – Material sampled at location S1**

Three samples were collected from various locations within the stockpile, as shown in Figure 6 to Figure 8.

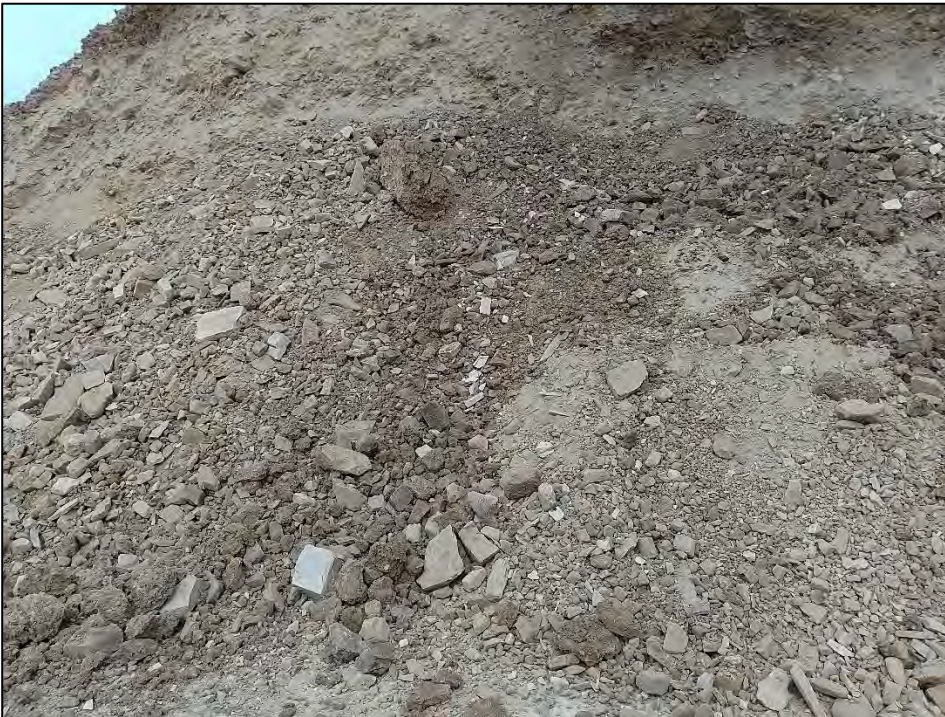
**Figure 7 – Material sampled at location S2**

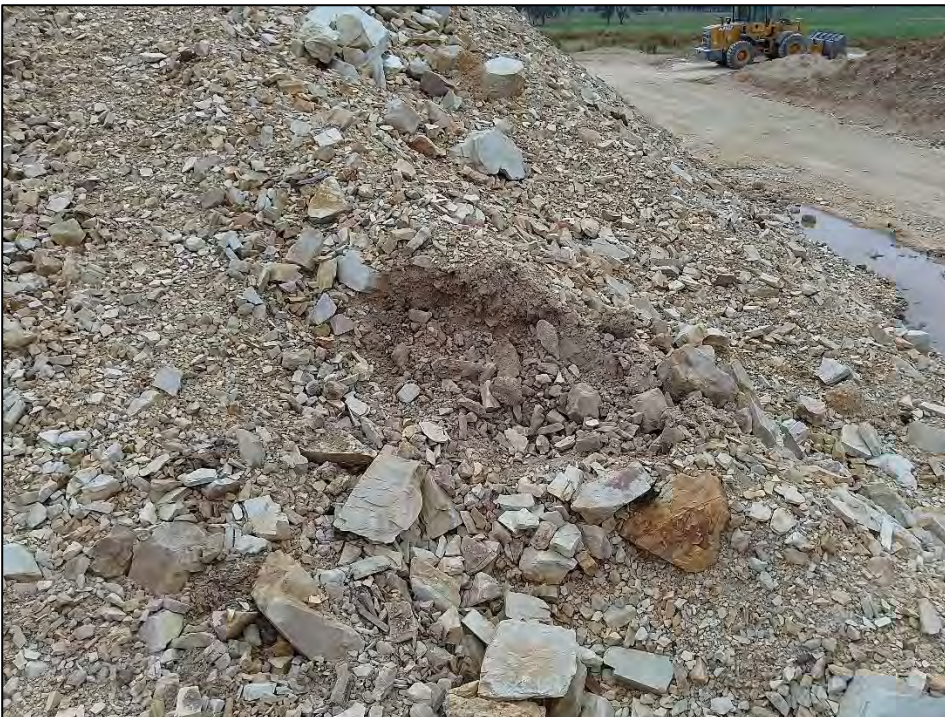
**Figure 8 – Material sampled at location S3**

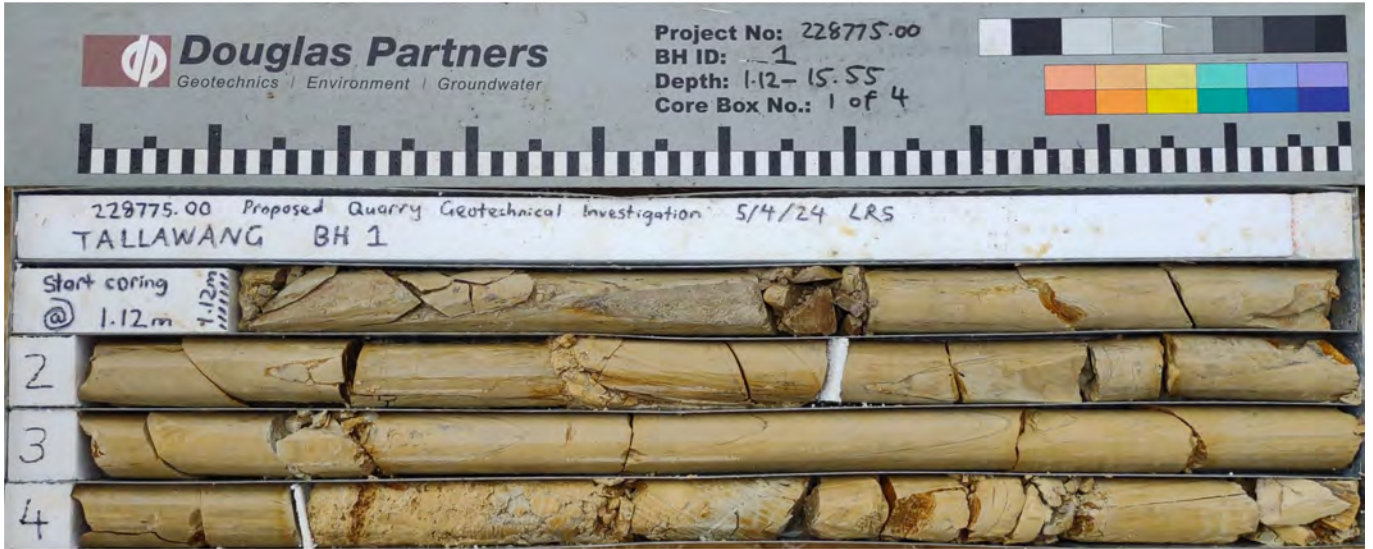
Box 1 of 4: 1.12-5.00 m depth

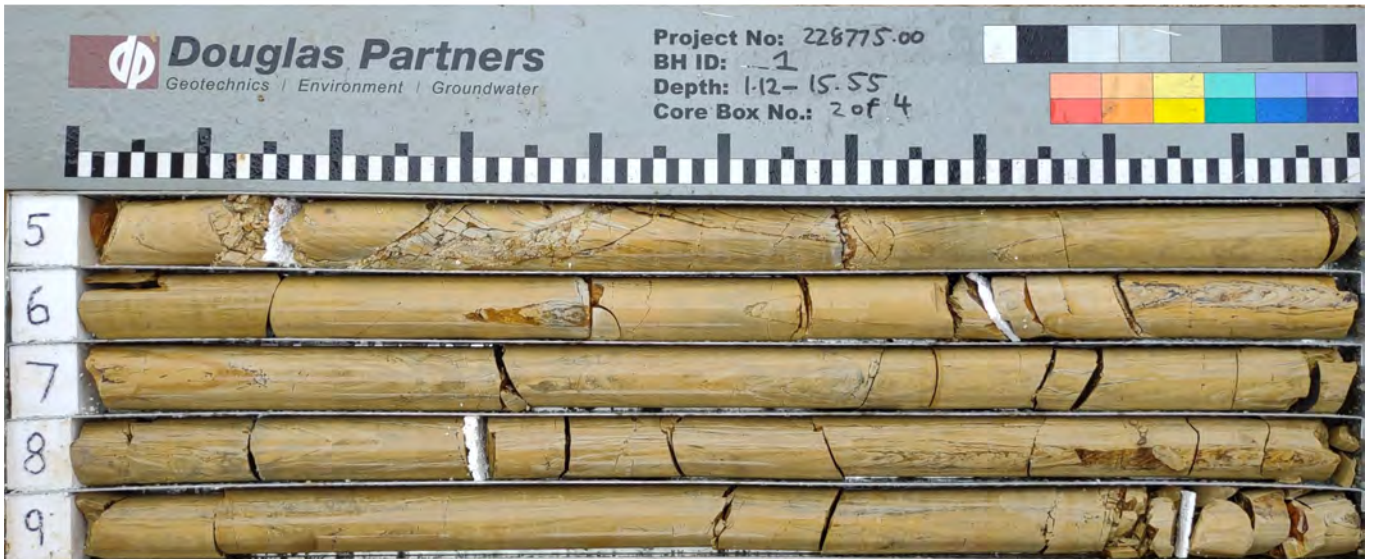
Box 2 of 4: 5.00-10.00 m depth

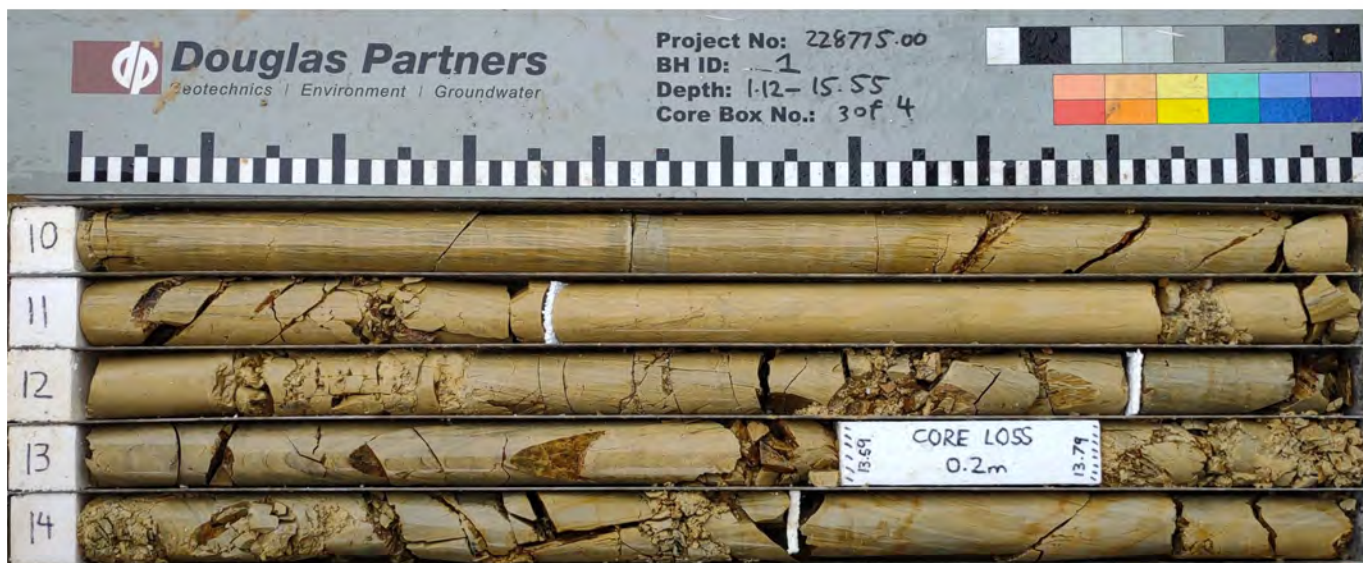
Box 3 of 4: 10.00-15.00 m depth

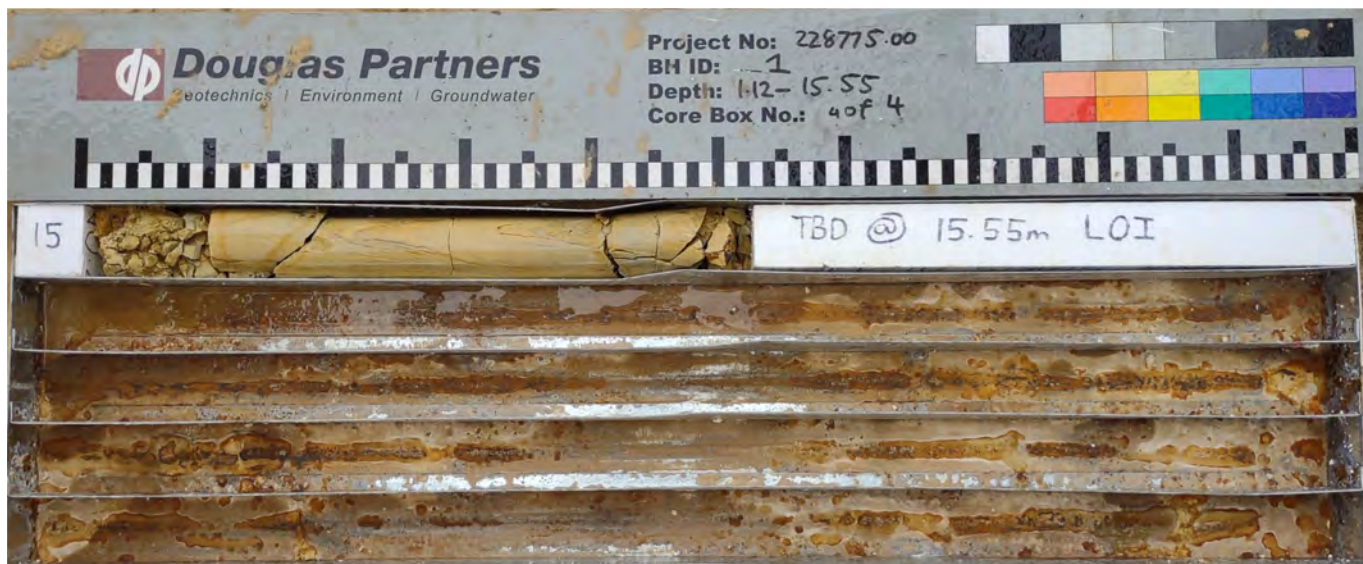
Box 4 of 4: 15.00-15.55 m depth

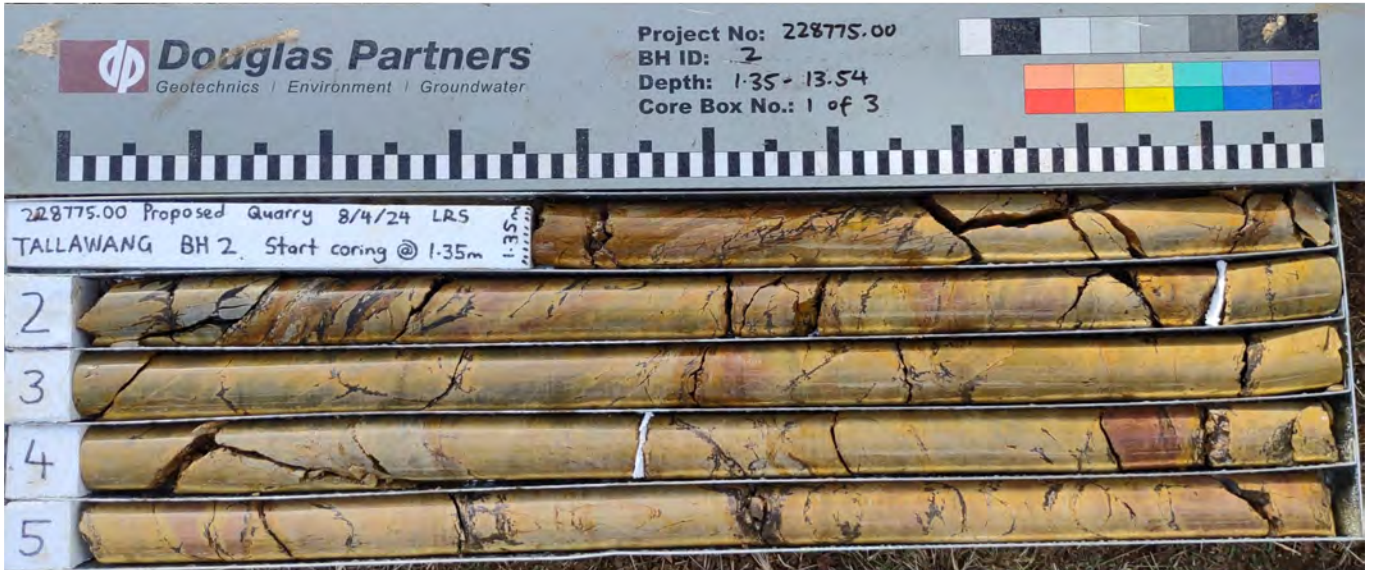
Box 1 of 3: 1.35-6.00 m depth

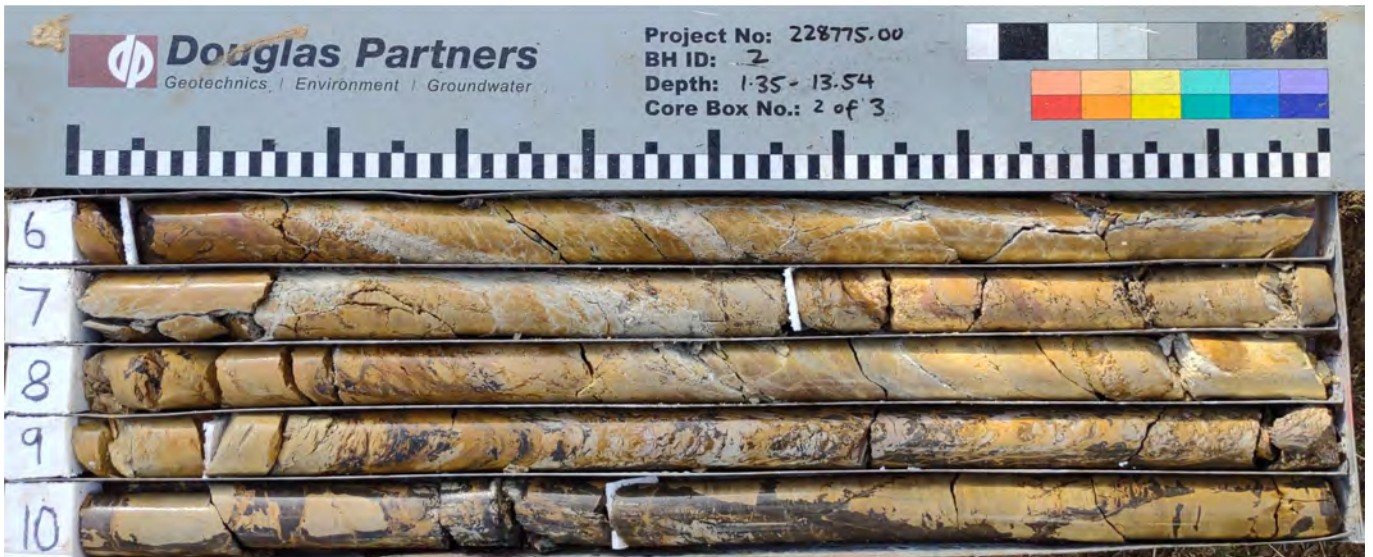
Box 2 of 3: 6.00-11.00 m depth

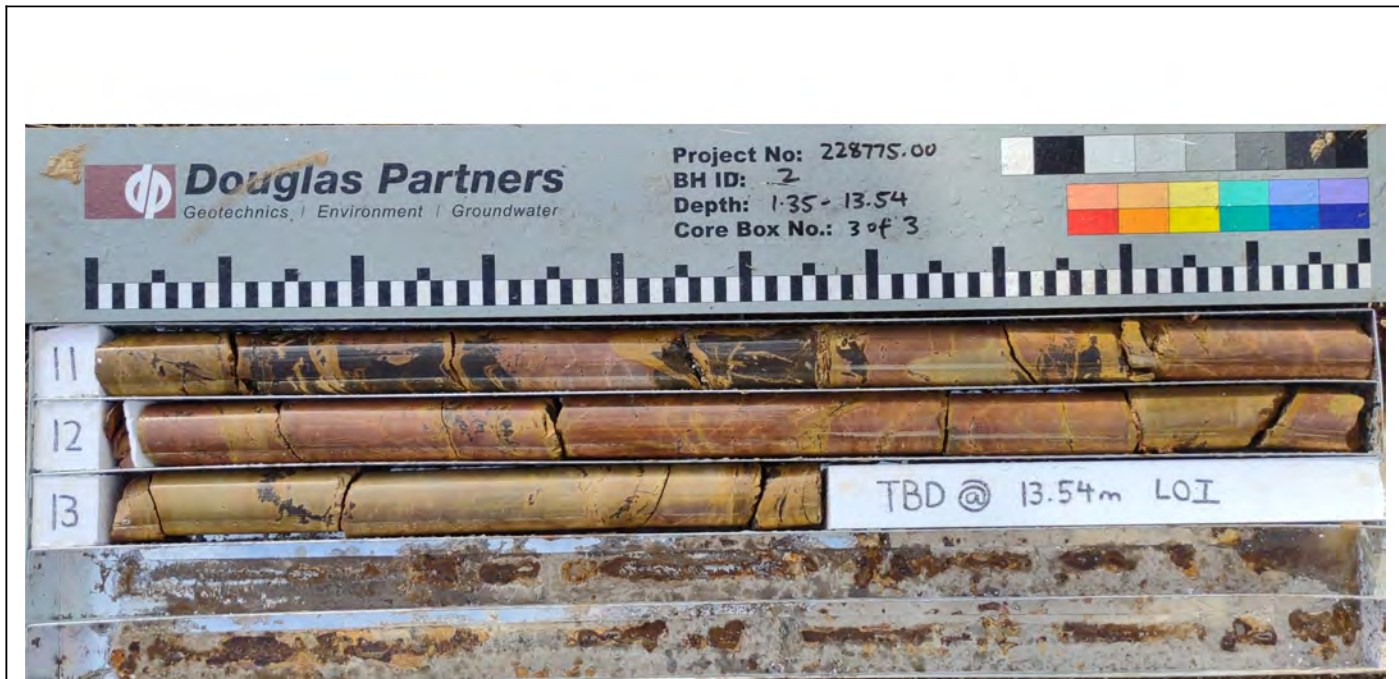
Box 3 of 3: 11.00-13.54 m depth
