Site Contamination Investigation

Site Address: Gowrie Childcare Centre - 39 Saleyards Lane,
Mudgee

Our Reference : 41821-ER01_A

Project Name:	Preliminary Site Contamination Assessment – Gowrie Childcare Centre - 39 Saleyards Lane, Mudgee
Client:	Gowrie NSW
Project Number:	41821
Report Reference:	41821 ER01_A
Date:	16/08/2024

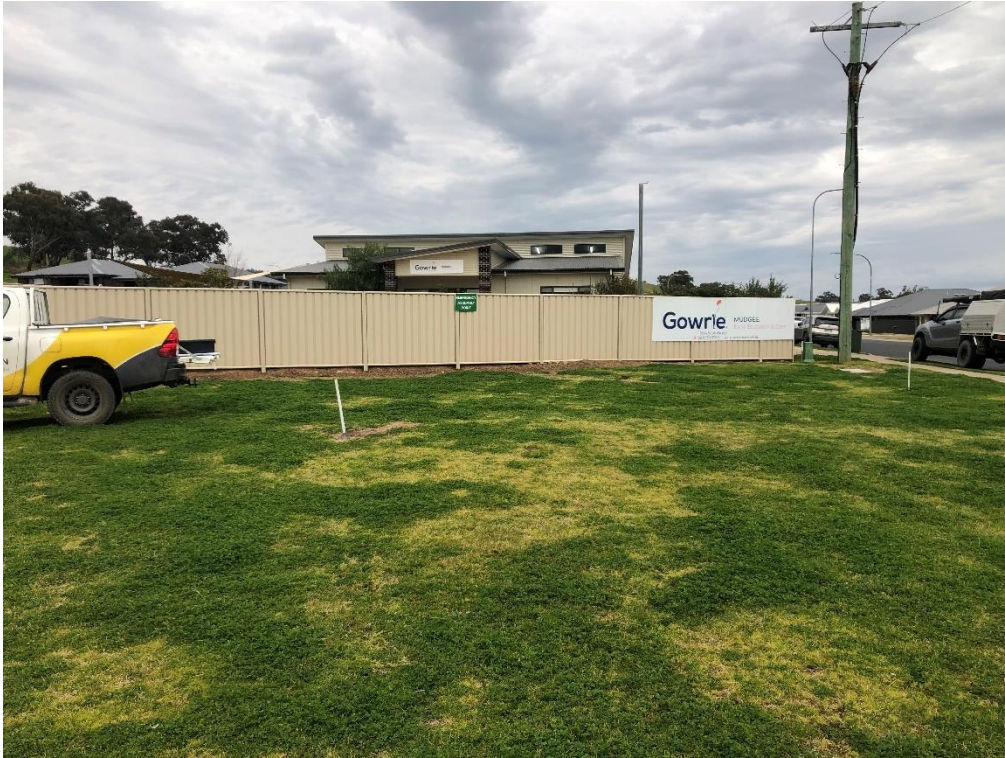
Figure 2.3: View of the existing childcare facility with the northern portion of the Investigation Area in the foreground.

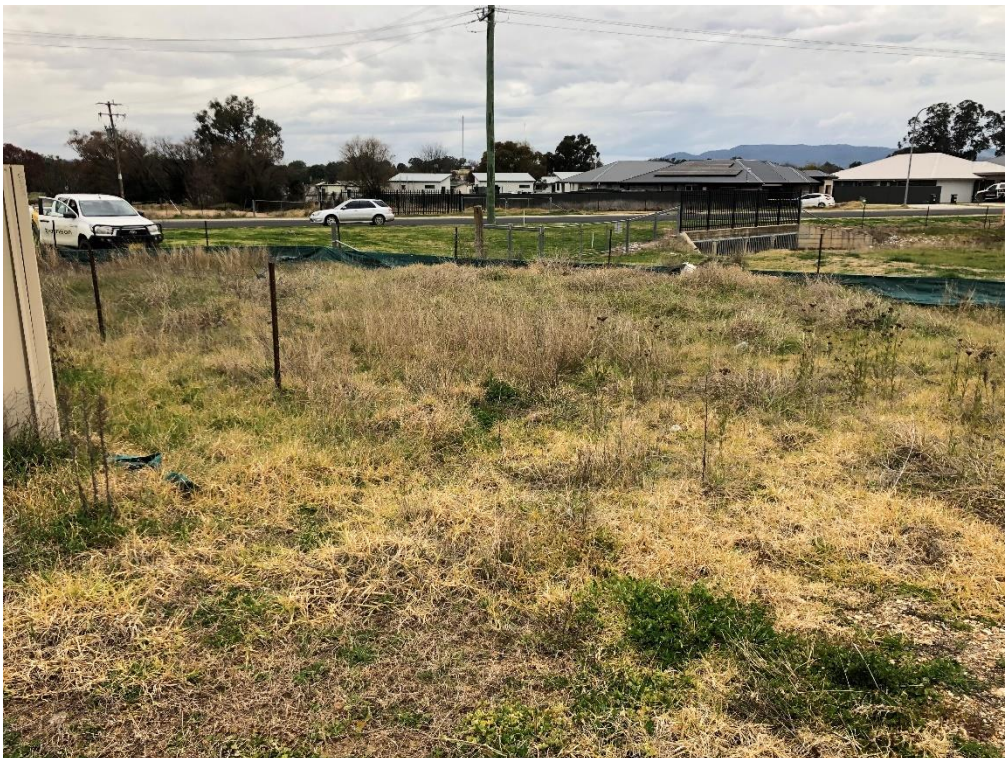
Figure 2.4: Remainder of unoccupied Investigation Area with watercourse and culvert under Saleyards Lane in the background.

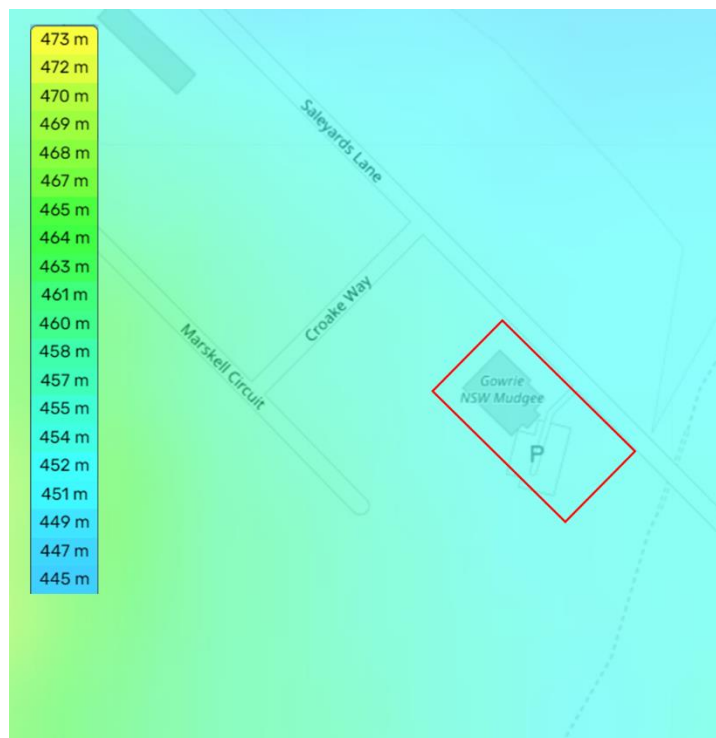
Figure 3.2 presents topographical information overlain on the map of the Subject Site. The presented data shows that the Subject Site is relatively flat throughout. Generally, the site and surrounding locality has a slight fall to the east, towards the nearby watercourse.

Figure 3.2: Subject Site topography.

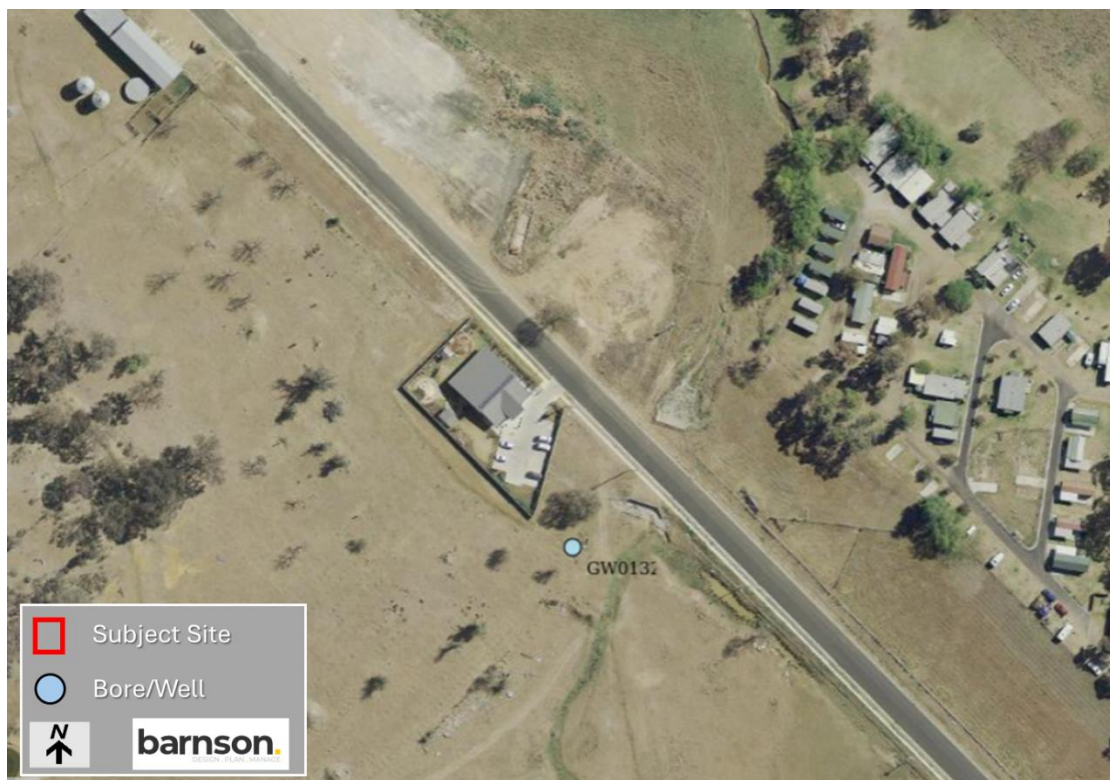
A review of existing groundwater bore records (WaterNSW, 2024) indicate there is a well located inside the boundaries of the Investigation Area. No other registered groundwater sites are identified within 500m of the Subject Site. The location of the well is indicated in Figure 3.3.

The information recorded in the database for the well (GW013263) indicate the depth as 10.6m. No information on Standing Water Level (S.W.L), Water Bearing Zone (W.B.Z) or yield is listed. The well was used for stock watering purposes.

Figure 3.3: Groundwater bores near the Subject Site.

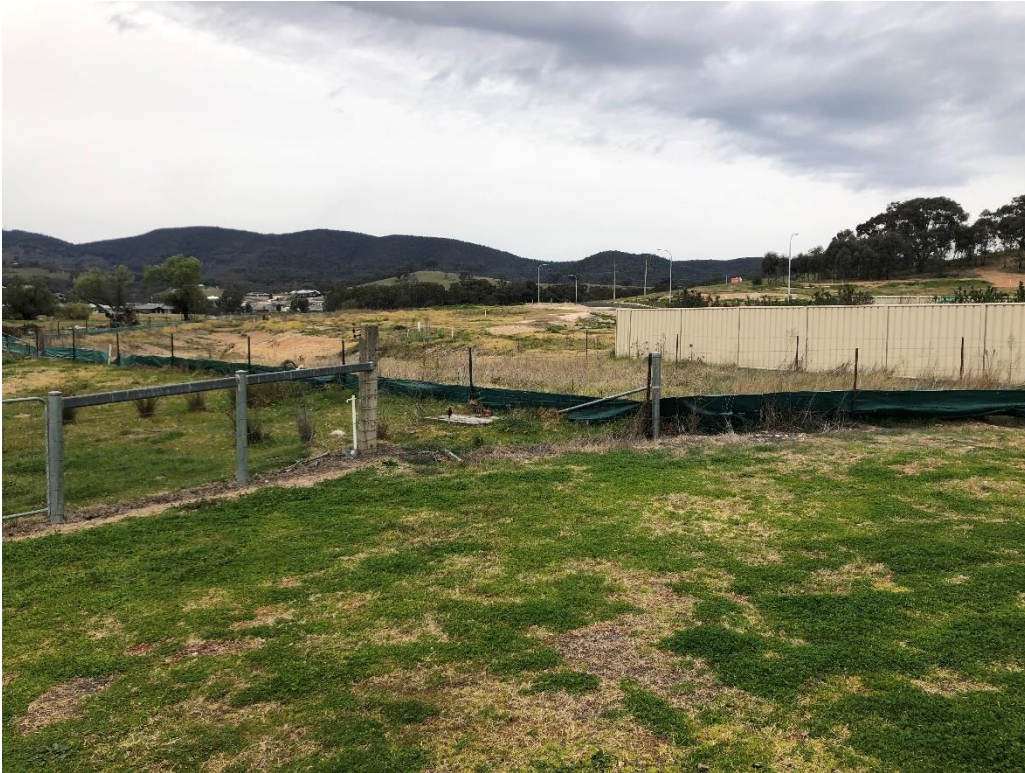
Figure 5.1: Maintained and unmaintained vegetation covering surface of the Investigation Area.

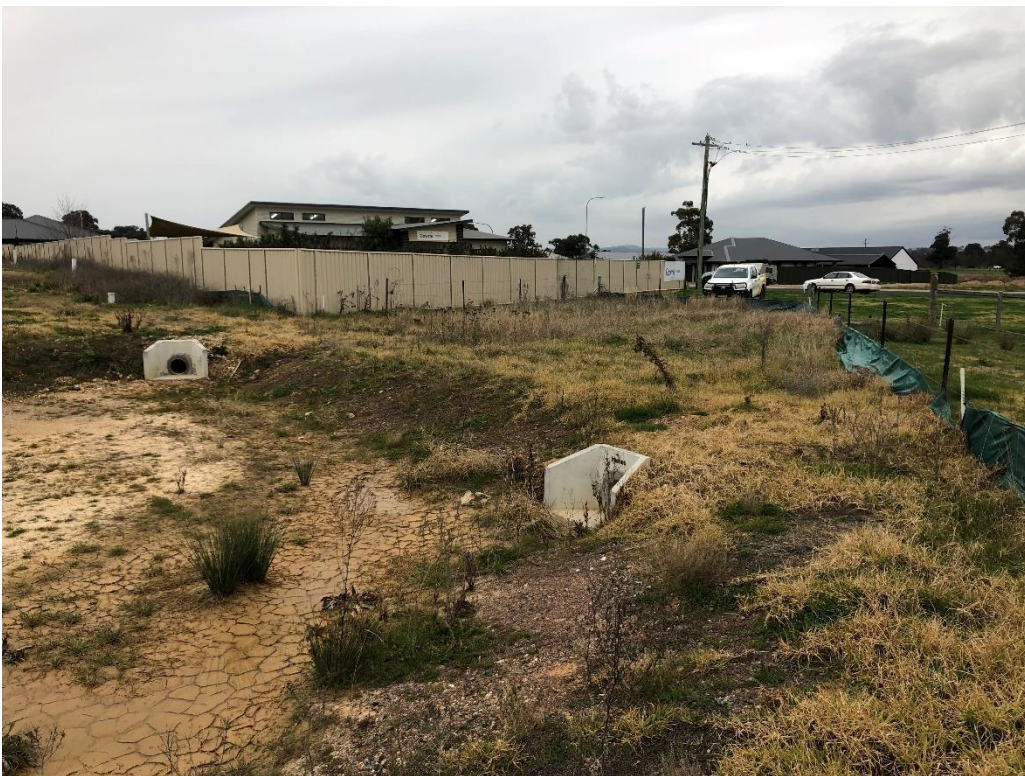
Figure 5.2: Evidence of earthworks to the south of Investigation Area

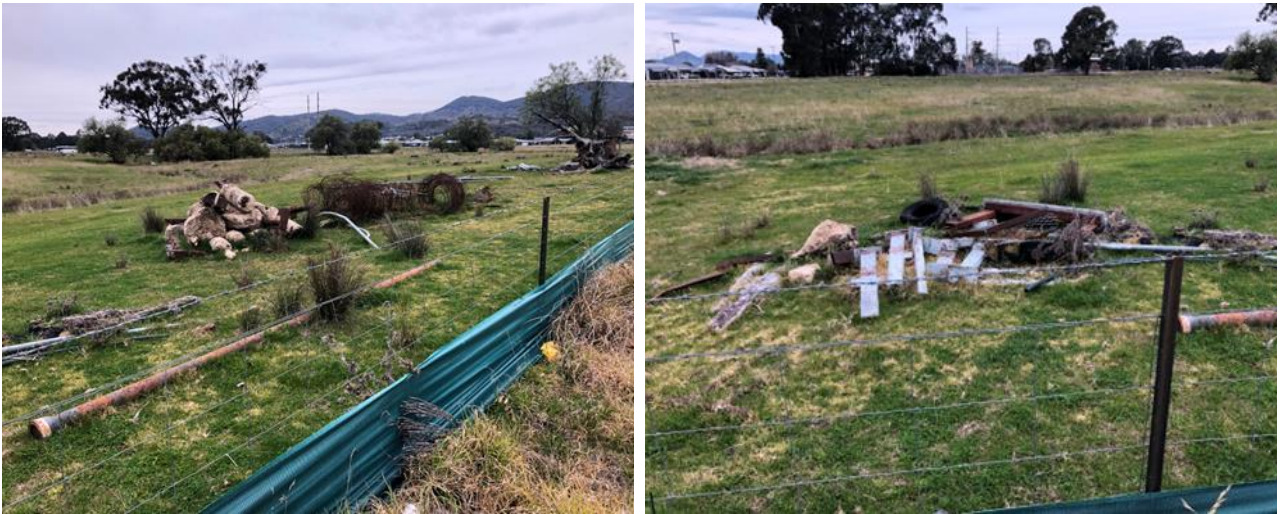
Figure 5.3: Waste stockpiles outside Investigation Area.

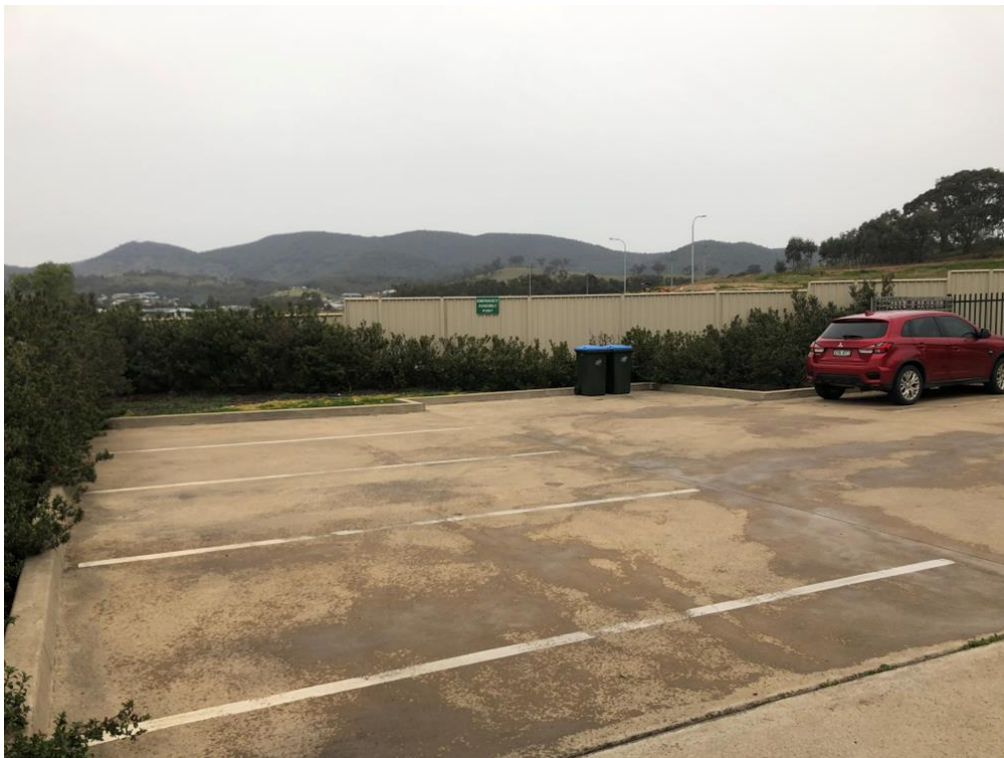
- Parking lot is concrete bunded. All stormwater is channelled to a stormwater pit. Contaminated runoff from the carpark is unlikely.
- Landscape area inside existing fenced parking area is covered with vegetation. Landscape soil used to fill area to height of kerb and sustain plants.

Figure 5.4: Existing parking lot.

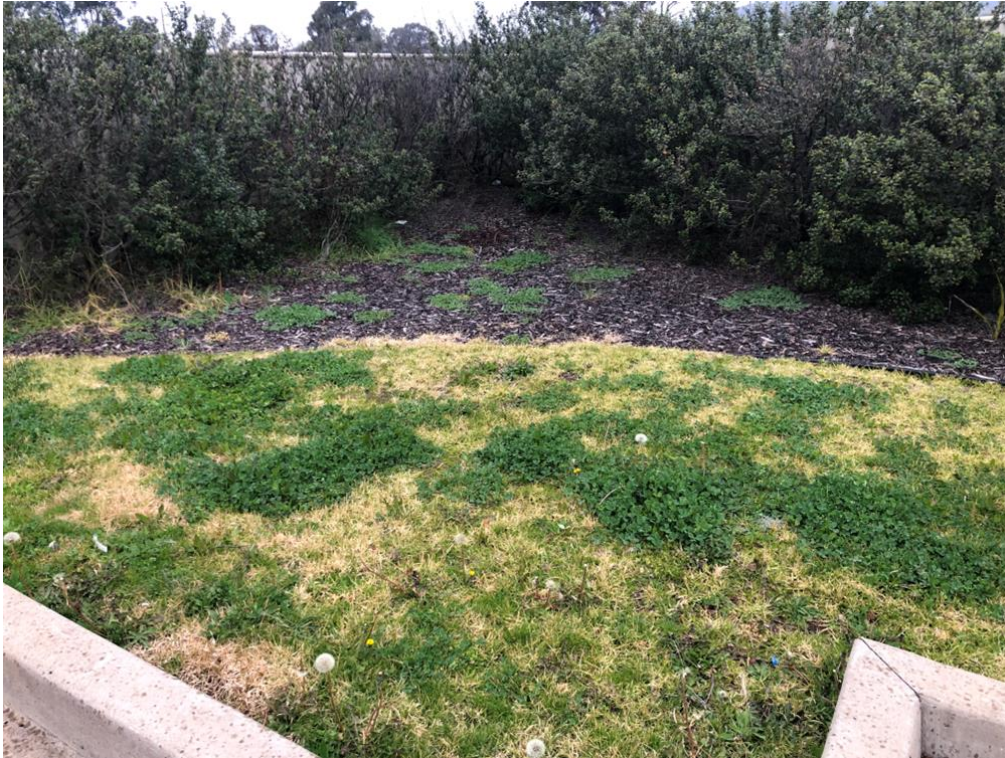
Figure 5.5: Landscape area in parking lot.

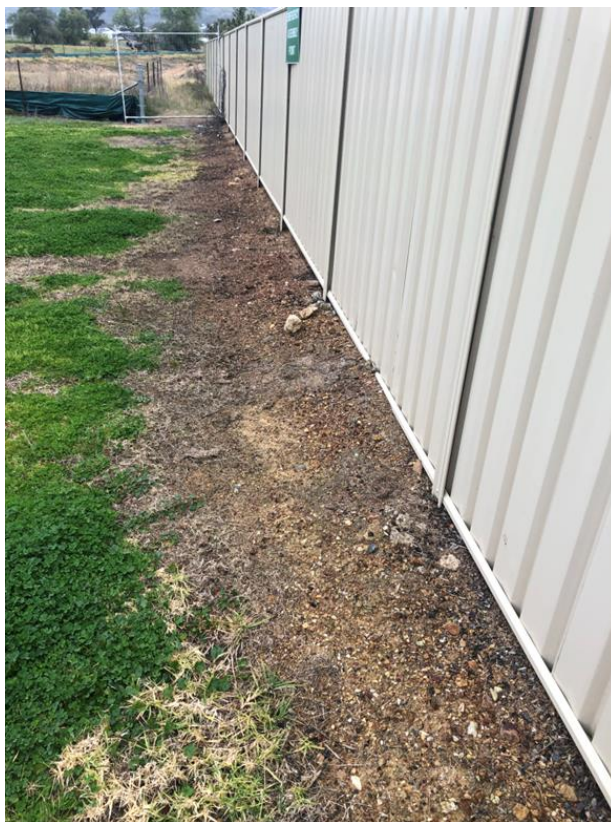
- Area immediately outside of childcare facility fence appears to be sprayed with herbicide to reduce the need for maintenance.

Figure 5.6: Bare soil next to existing facility fence.

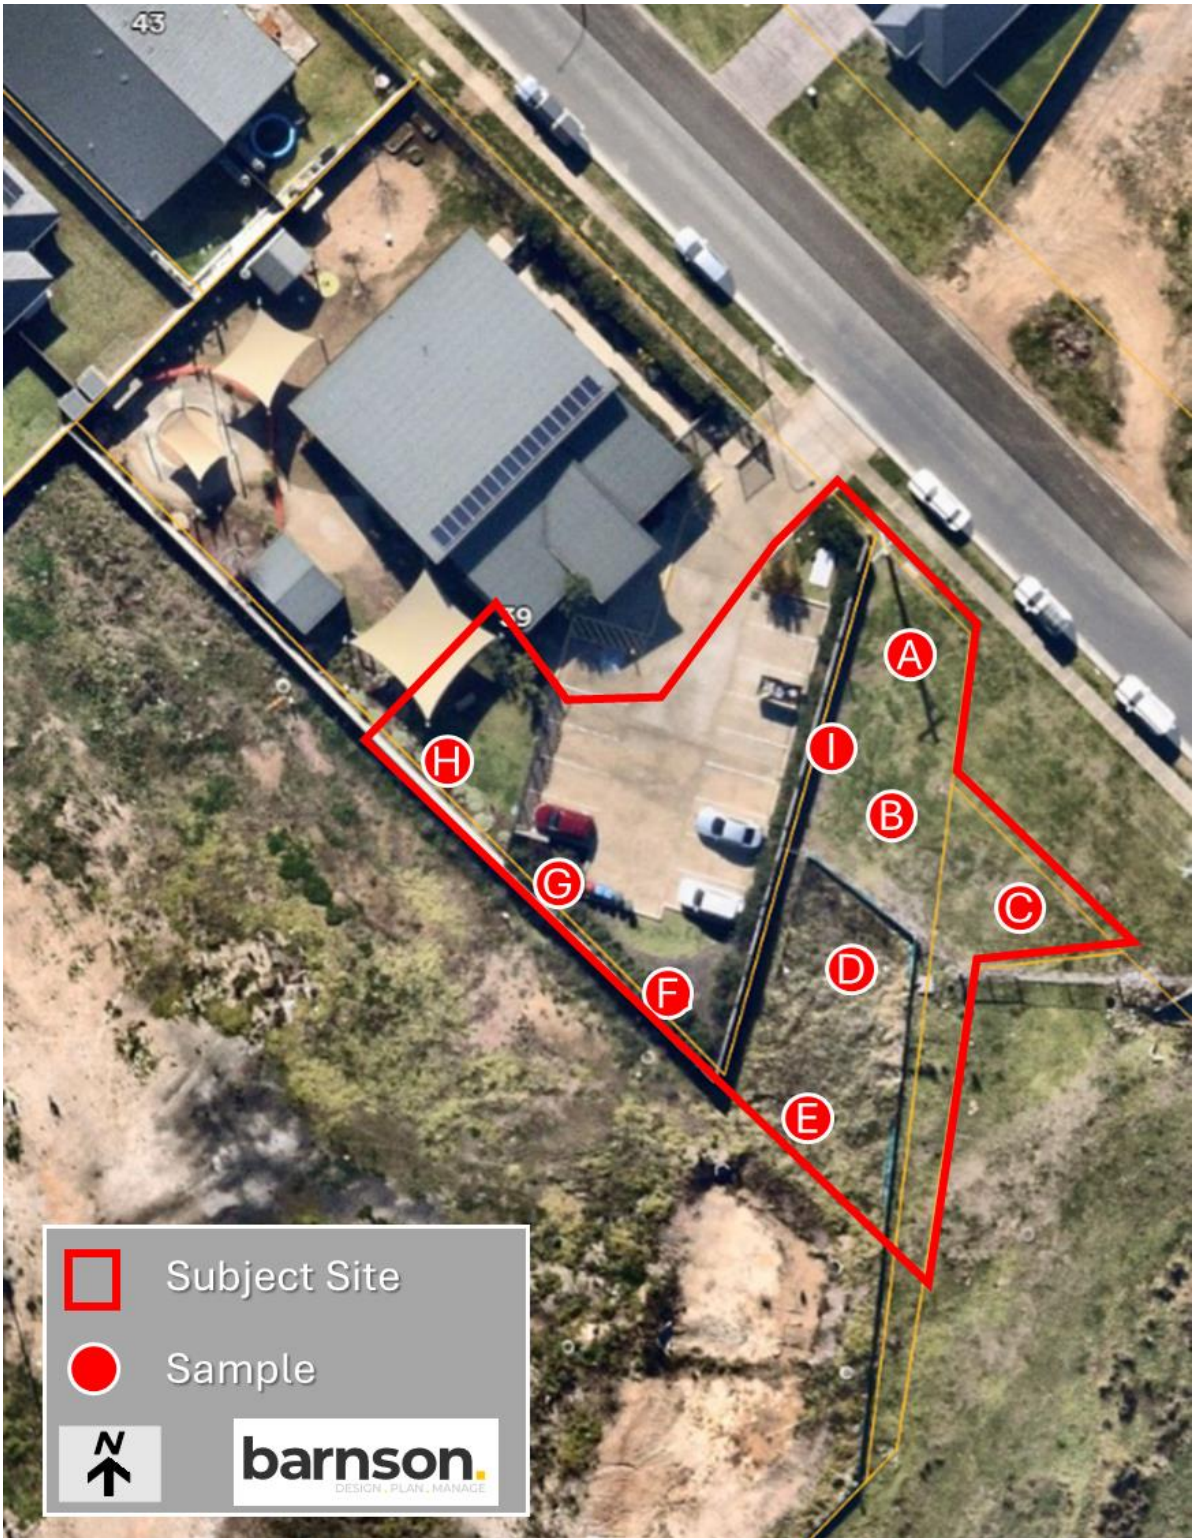
Figure 5.7 presents a map of the Subject Site with the locations of the surface soil samples indicated. Table 5.1 is a summary description of the collected samples.

Figure 5.7: Locations of confirmatory surface soil samples.
