# Residential Site Investigation Report

**Client:** Capstone Development Group

**Site Address:** 127 Gladstone Street  
Mudgee, NSW 2850

**Our Reference:** 43539-GR01\_A

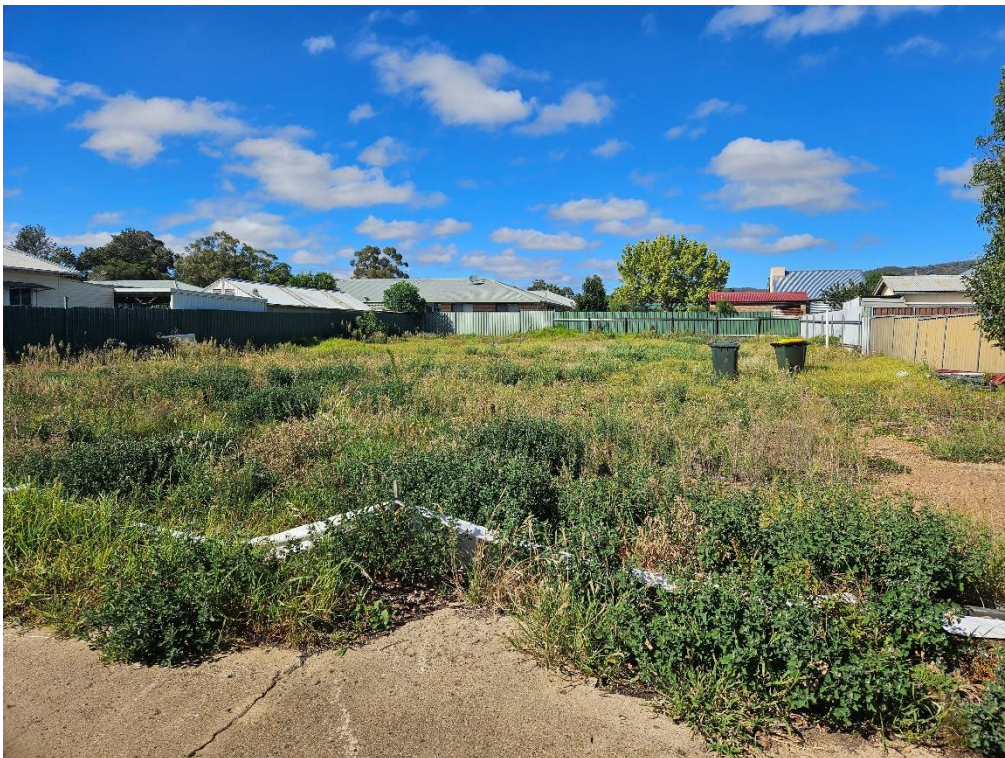
The site consists of moderate grass and weed cover with no trees onsite.

The site is sloping slightly to the north. The block has existing buildings and established houses in the vicinity.

Plate 1 – South facing view

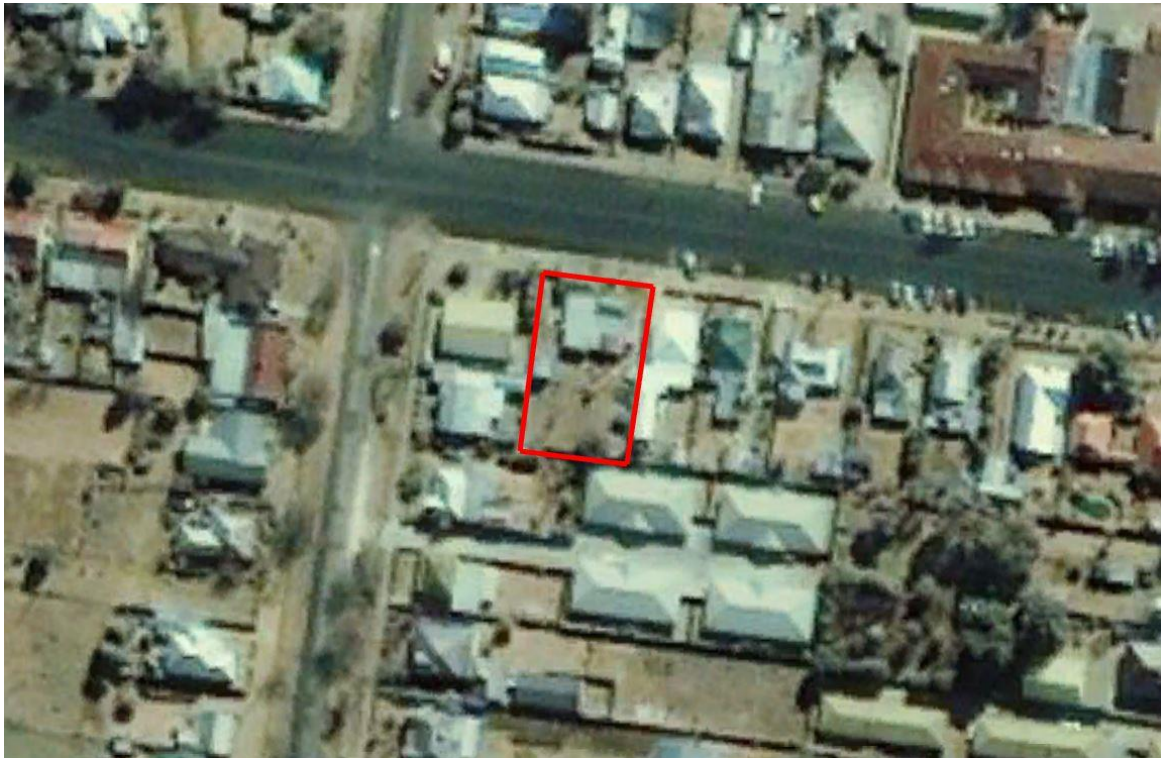
A review of Google Earth imagery of the site indicates that a building had existed on the site since before an image taken in 2002. Images exist back to 1985, yet the image is not clear enough to determine what was on the site. The building is expected to have been constructed well before 2002. The building has been removed from site, reference is made to AS2870 Clause 1.3.3 (a) Abnormal moisture conditions. See 2002 aerial image below:

Plate 2 – Aerial Image 2002, Courtesy Google Earth.

- A building has been removed from the site; reference is made to AS2870 Clause 1.3.3 (a) Abnormal moisture conditions.

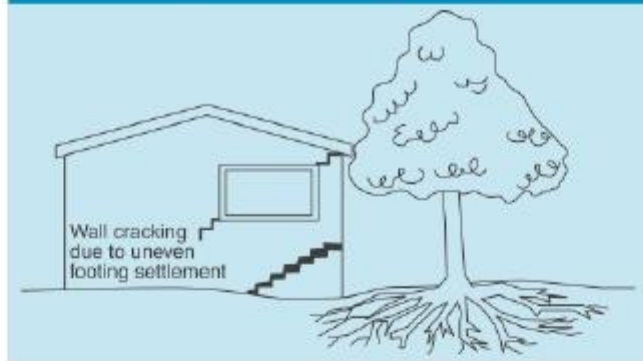
### Trees can cause shrinkage and damage

As the weather pattern changes and the soil begins to dry out, the external footings will be first affected, beginning with the locations where the sun's effect is strongest. This has the effect of lowering the external footings. The doming is accentuated and cracking reduces or disappears where it occurred because of dishing, but other cracks open up. The roof lines may become convex.
